SUBJECT: NASA CONTRACT NO. NASW-4301
PRELIMINARY ASSESSMENT/SITE INSPECTION
JET PROPULSION LABORATORY

SUMMARY

POTENTIAL HAZARDOUS WASTE SITE
PRELIMINARY ASSESSMENT
PART 1 - SITE INFORMATION AND ASSESSMENT

**POTENTIAL HAZARDOUS WASTE SITE
SITE INSPECTION REPORT
PART 1 - SITE LOCATION AND INSPECTION INFORMATION**

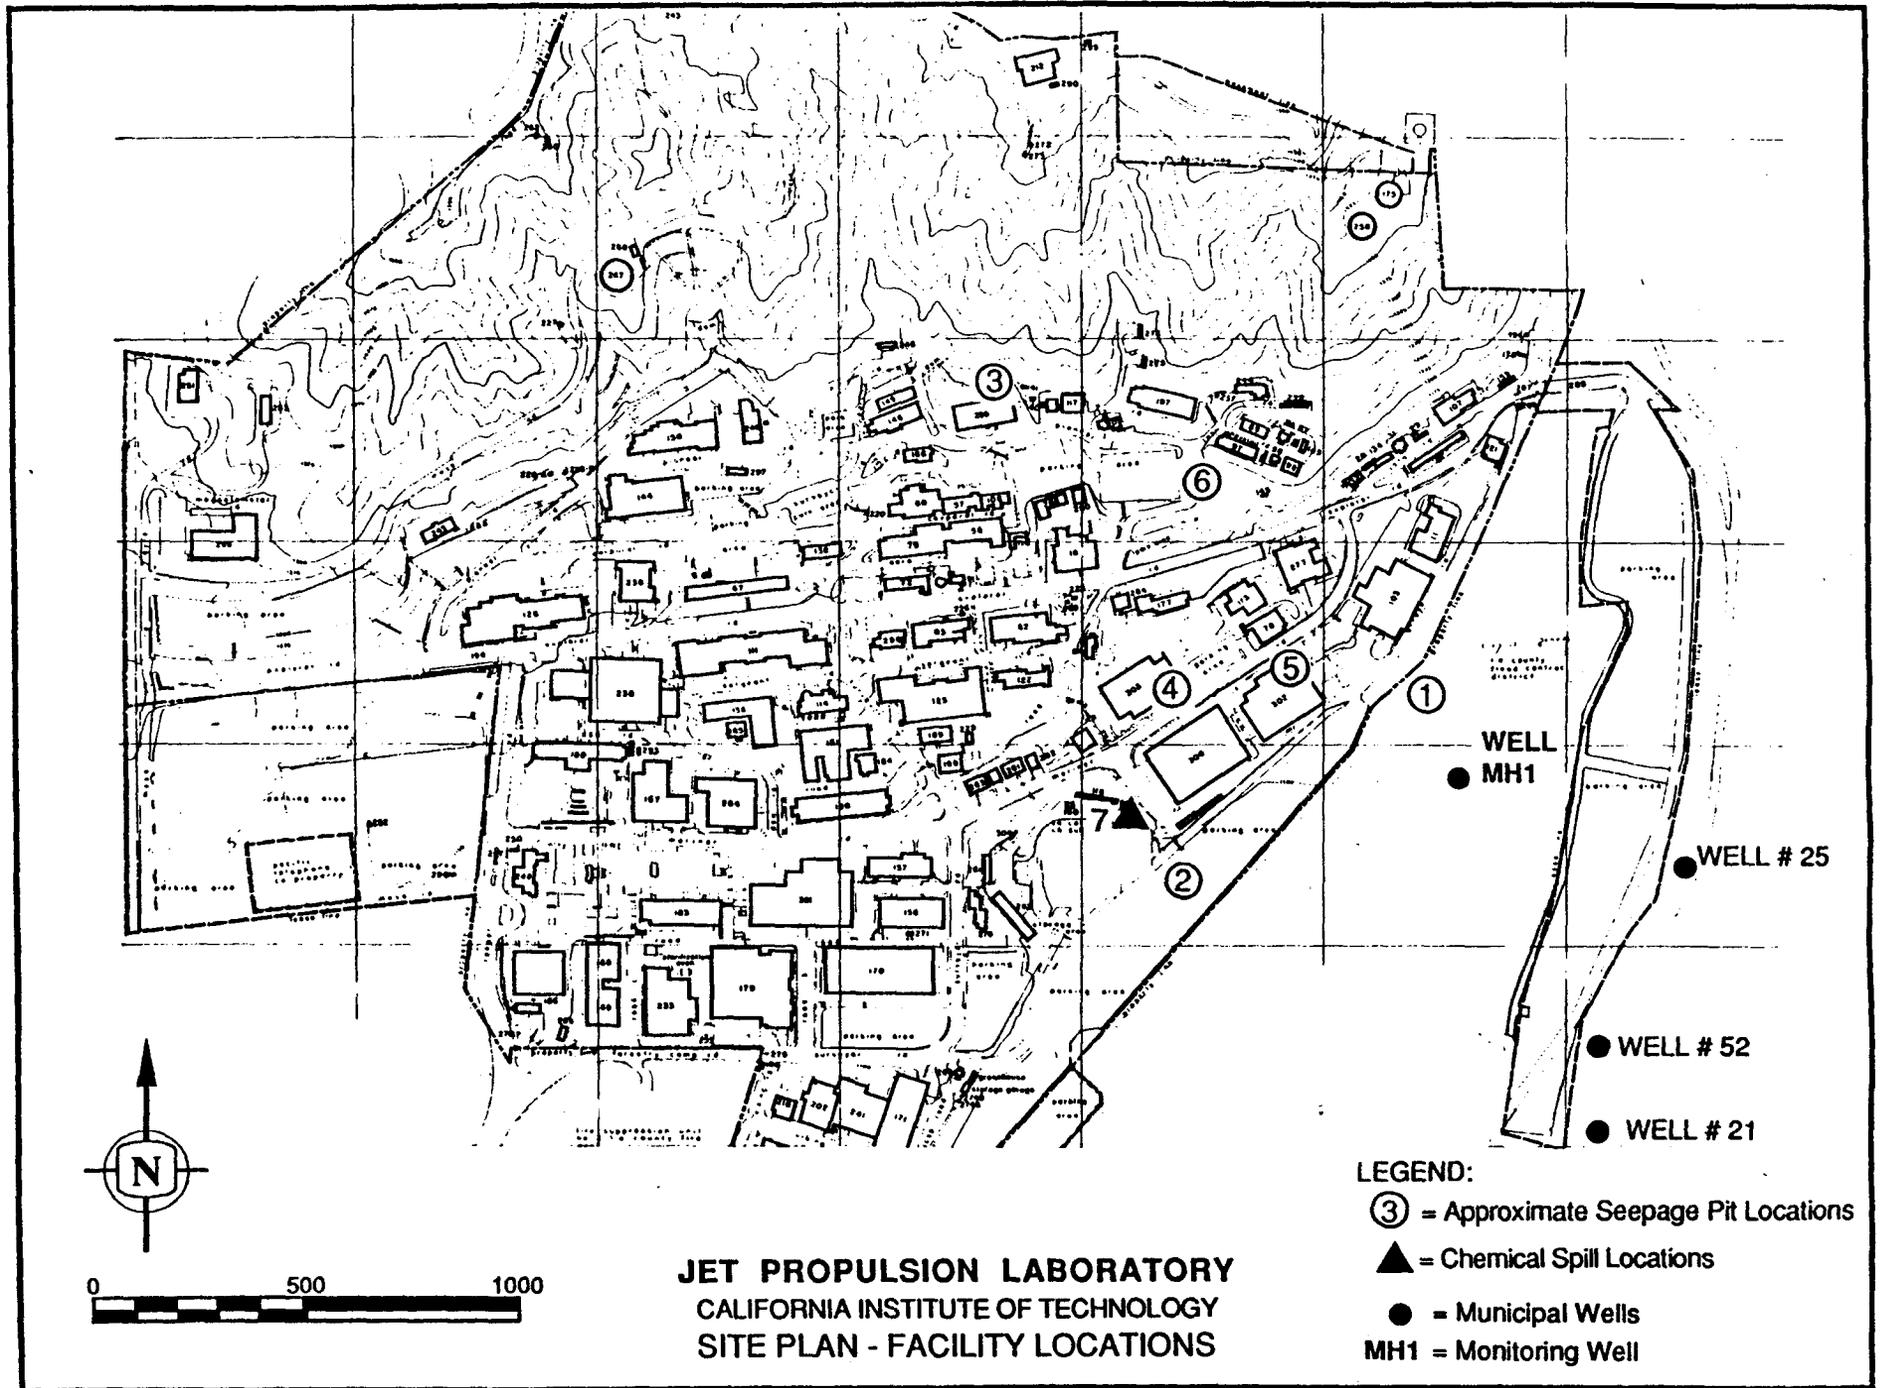
- a. Seepage Pit #1 near Building #103 (see Map Location #1). The site was located outside of the JPL fence in the Arroyo Seco dry wash, at the southeast corner of the lab. This site was approximately 15

- b. Seepage Pit #2 near Arroyo Parking Lot (see Map Location #2). This site was located below the Southern California Edison substation, approximately 50 yards from the end of the main storm drain that empties into the Arroyo Seco wash. This pit was approximately 30 feet wide and 15 feet deep. The pit is believed to be under the existing parking lot. Wastes disposed at this pit were similar to those at Pit #1. The site was also used for burning debris, and for disposal of fluorescent lights and waste magnesium. No sampling of this pit has been conducted.

- c. Seepage Pit #3 near Building #117 (see Map Location #3). This disposal pit was located just northwest of two current day bunkers #140 and #141, used for storing propellants. The pit was approximately 30 feet deep, and was used primarily for the disposal of propellants and mixed solvents. No sampling of this pit has been conducted. Seepage pits #1, #2, and #3 received chemical wastes over the period 1954-1958 according to JPL personnel.

- d. Seepage Pit #4 near Building 303 and former building 59 (see Map). This pit was used exclusively for disposal of chemistry lab wastes. This pit location was investigated down to a depth of 11 feet in 1984 by R.C. Slade.⁽¹⁾ Lead concentrations (200 ppm) were found above normal levels. No other contaminants were found.

- e. Seepage Pit #5 near Building 302 and former building 65 (see Map). This pit was also used exclusively for disposal of chemistry lab wastes. R.C. Slade also investigated this pit and didn't find any contaminants above normal levels down to 11 feet.

- f. Seepage Pit #6 near Building 97 (see Map). This was the former site of a chemistry lab that used this pit for disposal of lab wastes. R.C. Slade investigated this pit to 11 feet and no contaminants above normal levels were found. Disposal in Pits #4, #5, and #6 occurred during the approximate period of 1941-1960.

- g. Past Spills Near Chemical Storage Building (Building 187). According to JPL personnel, waste solvents were historically dumped onto the soils near this storage building. No sampling has ever been conducted to confirm any contamination.

Due to the nature of past JPL waste disposal activities and the current contamination of downgradient municipal water supply wells, a Site Inspection of JPL should be conducted.

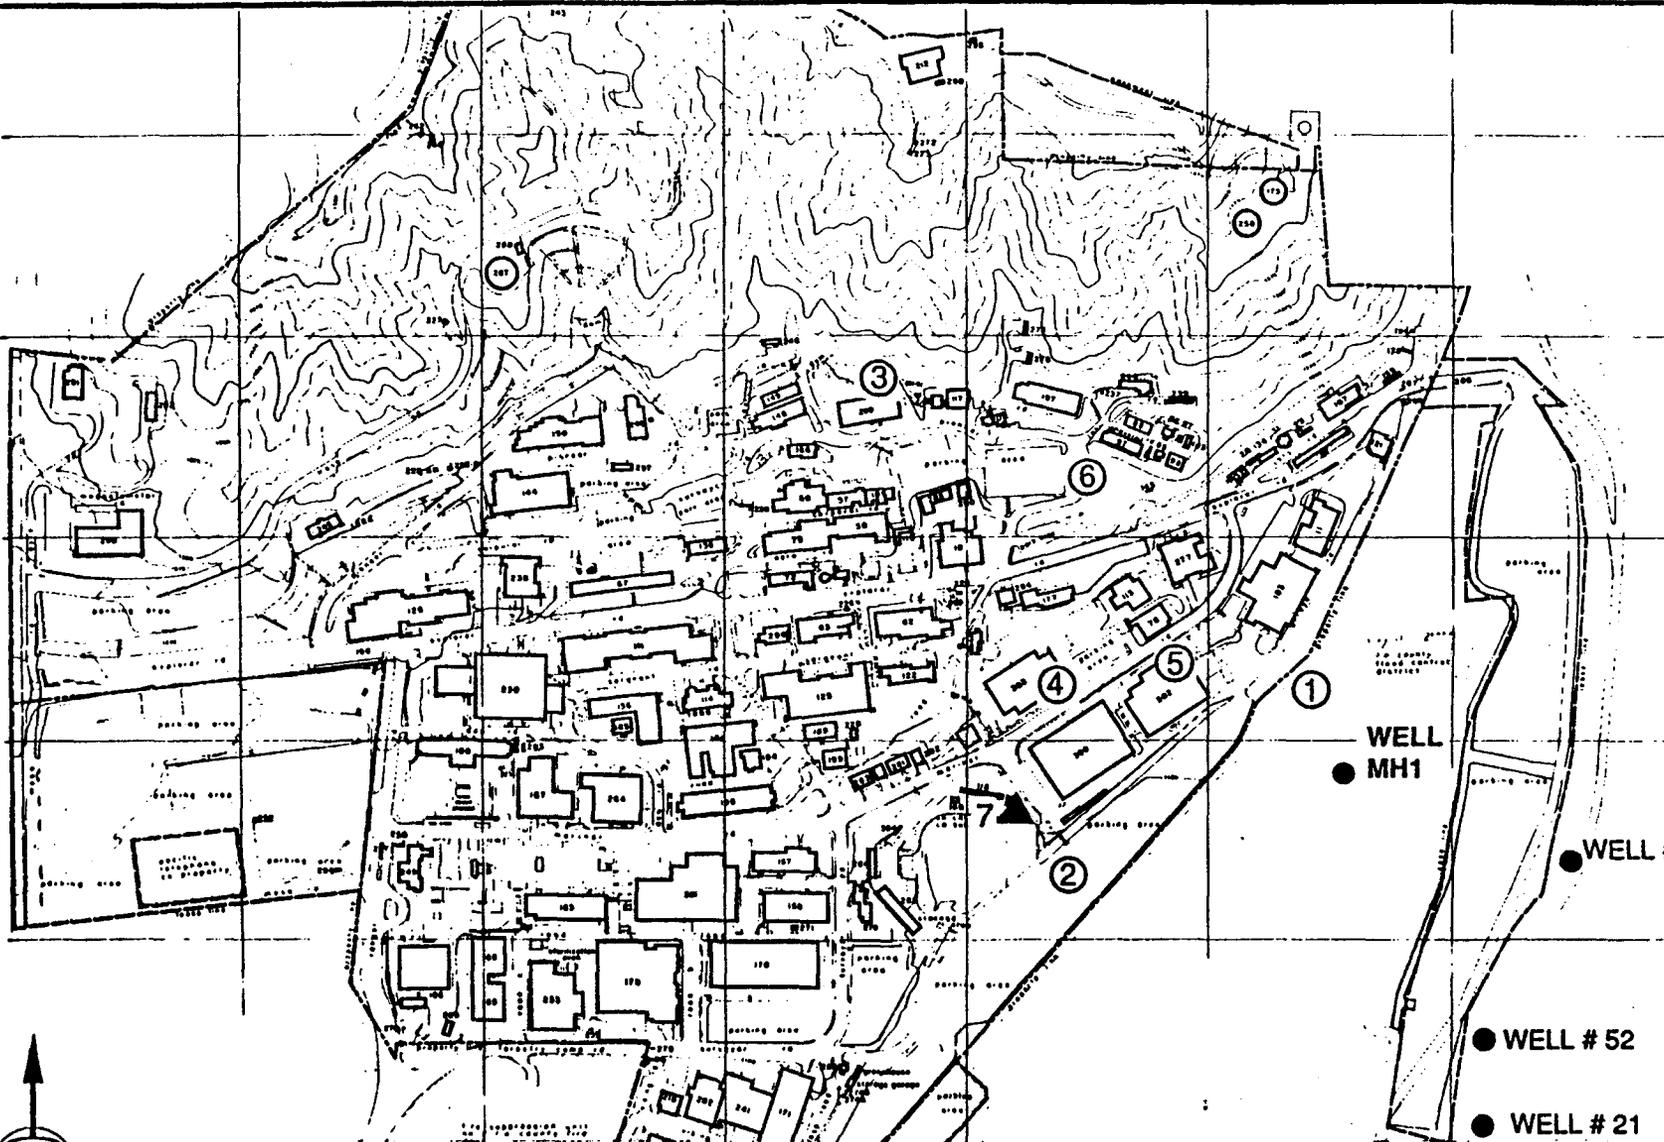
JET PROPULSION LABORATORY
CALIFORNIA INSTITUTE OF TECHNOLOGY
SITE PLAN - FACILITY LOCATIONS

- LEGEND:**
- ③ = Approximate Seepage Pit Locations
 - ▲ = Chemical Spill Locations
 - = Municipal Wells
 - MH1 = Monitoring Well

JPL should receive a high priority for further hydrogeologic studies due to the severity of the on-site contamination sources. The high HRS score of 38.3 is reflective of the high public health risk due to the contamination of the City of Pasadena's water wells. Additional studies should focus on the 6 seepage pits, the chemical spill site near Building 187, and continued monitoring of the municipal wells. The Army Corps of Engineers is currently conducting a remedial investigation surrounding the JPL Site, and efforts should be made to coordinate future work with the Corps of Engineers.
