NAS7.10550
NASA-JPL
SSIC No. 9661

FINAL
FIRST FIVE-YEAR REVIEW REPORT

National Aeronautics and Space Administration
Jet Propulsion Laboratory
Pasadena, California

February 2012

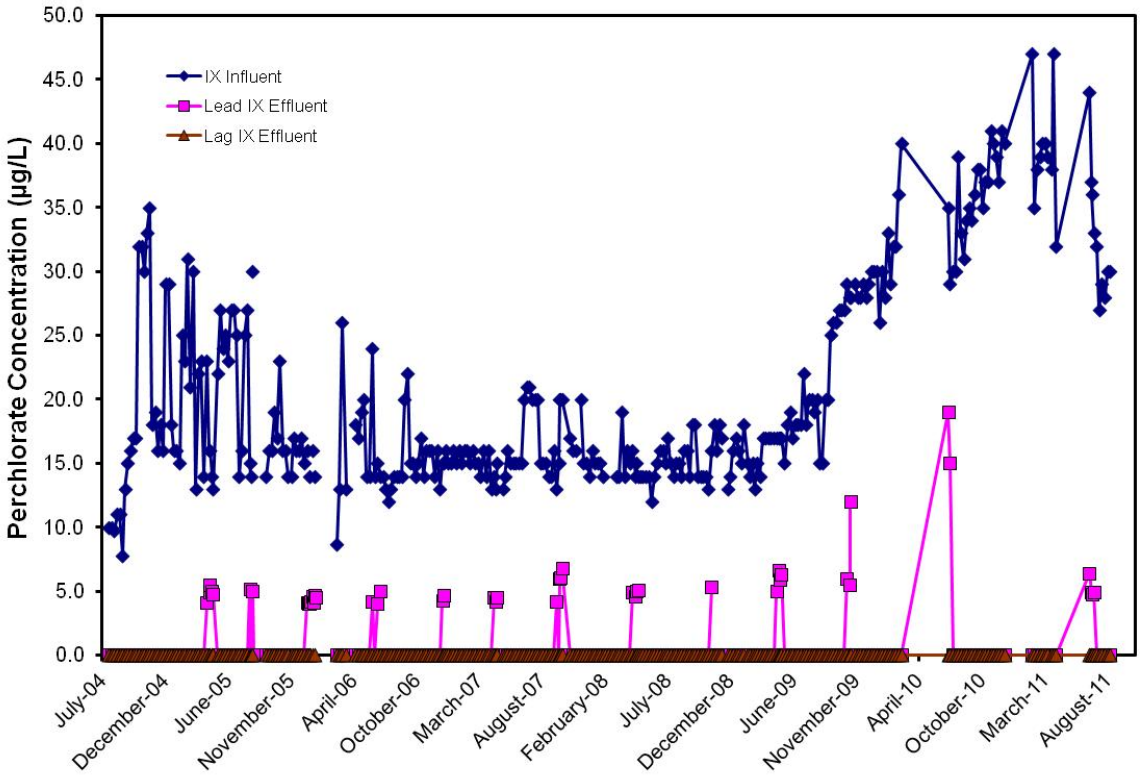
Figure 4-5. Ion Exchange System Performance

Influent perchlorate concentrations showed a generally decreasing trend from 2004 through 2009. However, perchlorate concentrations increased during 2010 because LAWC#3 concentrations have increased slightly and LAWC#5 was offline (Figure 4-5). The system operated effectively, removing perchlorate to below detectable levels at the effluent of the lag ion exchange vessel. Resin is changed out in the lead ion exchange vessel when perchlorate breakthrough in that vessel is detected. The ion exchange vessel with fresh resin is then placed in the lag position. Resin change outs are typically required two to three times per year (NASA, 2011c).

The annual O&M costs estimated during preparation of the interim ROD were approximately $923,500 for the LAWC treatment system and $3,080,900 for the MHTS (NASA, 2007b). This cost includes labor, materials, equipment leases, electricity, laboratory costs, and reporting/project management, but does not include costs associated with groundwater monitoring. Table 4-5 summarizes the annual O&M costs incurred for operation of the LAWC treatment system from the time of the interim ROD through the end of the last calendar year. With the exception of 2007, actual costs incurred were approximately equal to the estimated costs. In 2007, an additional resin change out event was required due to damaged resin.

Following this event, a new resin vendor was contracted at the site and the resin procurement process was changed. These events resulted in a higher than expected annual operating cost in 2007.

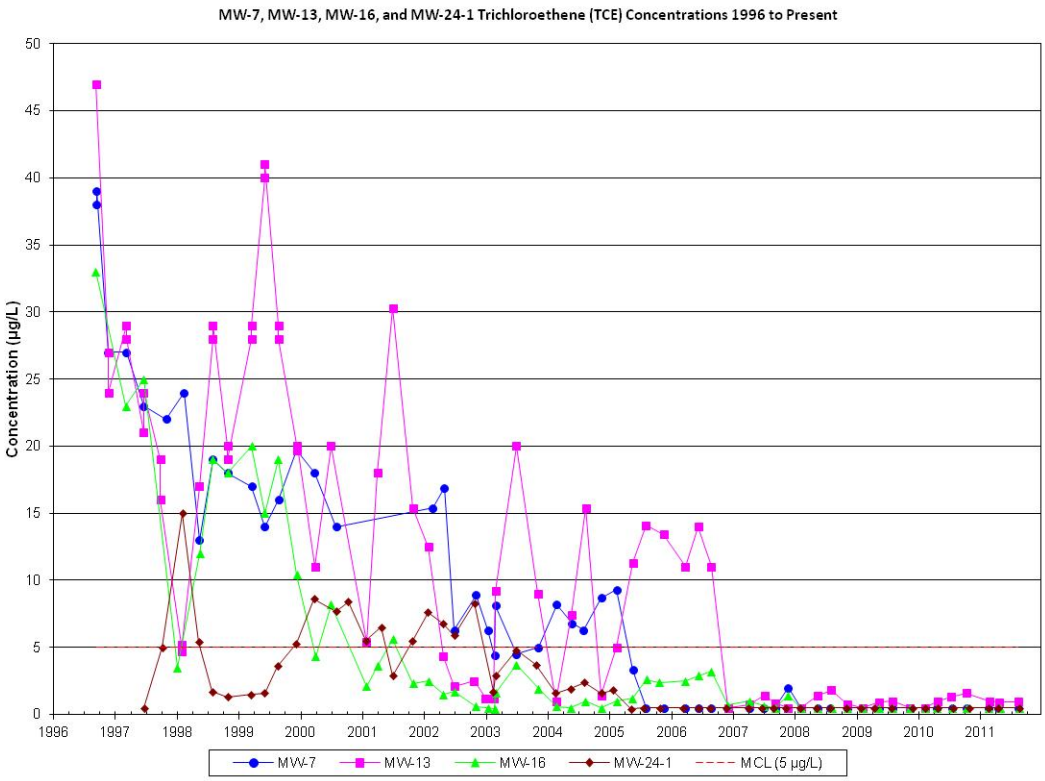
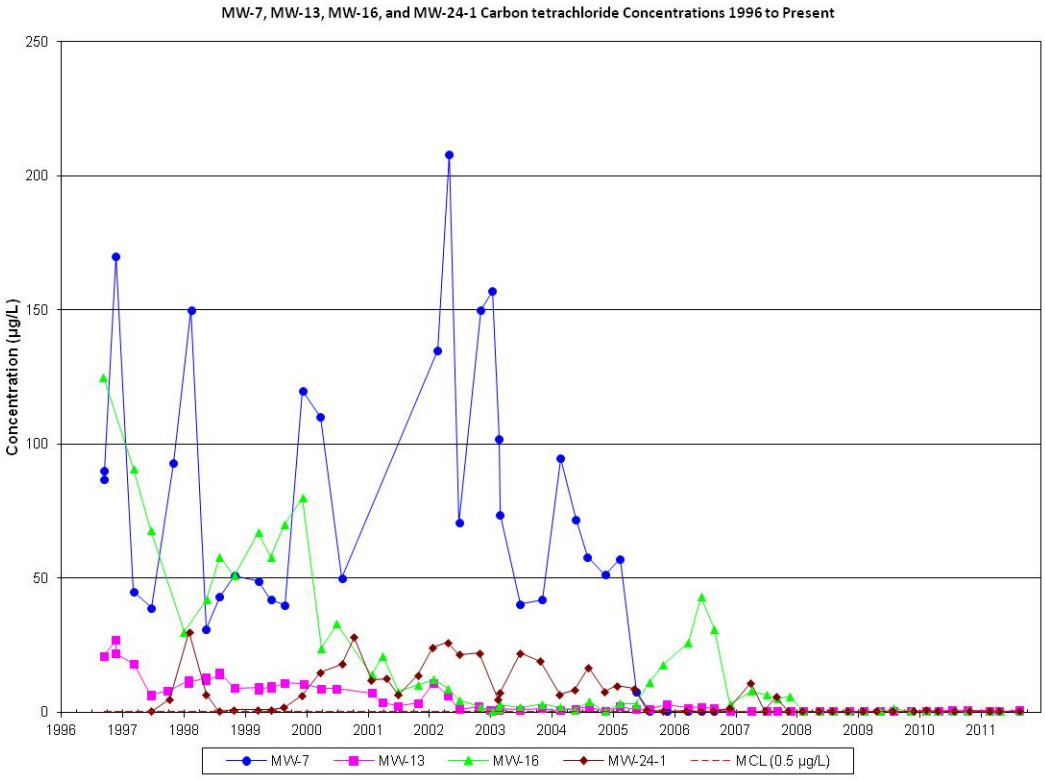
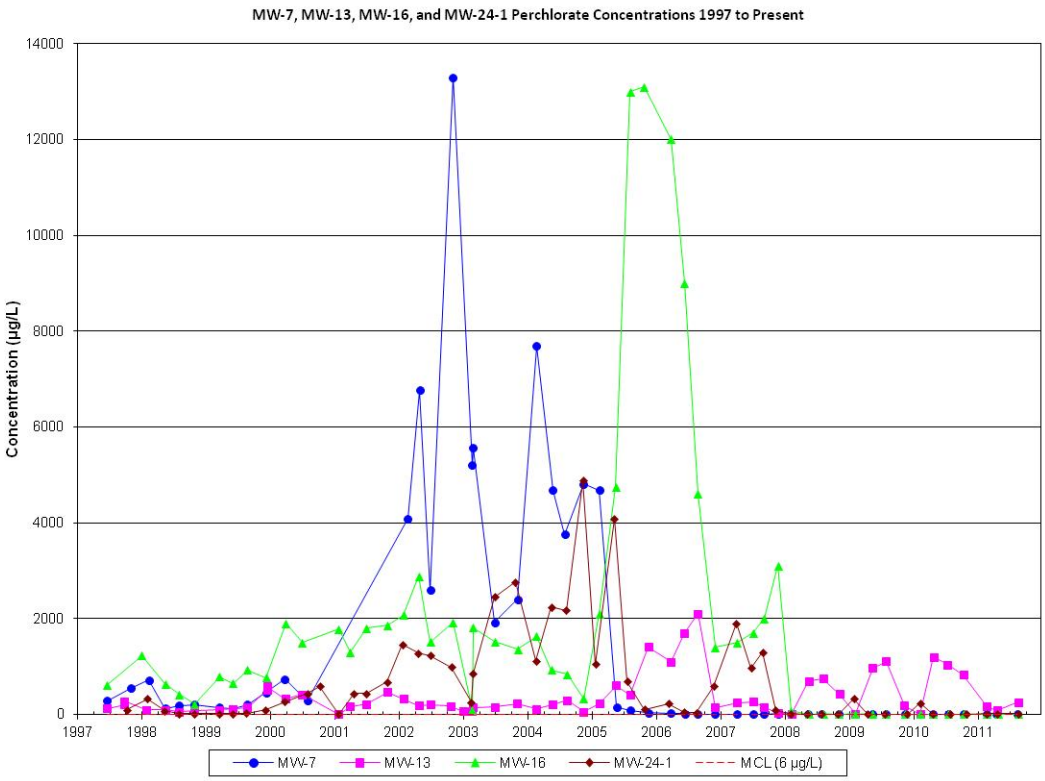
Isoconcentration contour maps (Figures 7-3 through 7-5) are provided for trichloroethylene, CCl_4, and perchlorate for baseline conditions before operation (October/November 2004) and for the most recent

- The concentration of VOCs and perchlorate in the treatment zone (i.e., MW-7, MW-13, MW-16, and MW-24) has decreased significantly since system startup.
- Concentrations of TCE in the treatment zone are below the state and federal MCL (5.0 µg/L).
- CCl_4 was detected in MW-13 (0.5 µg/L) at a concentration equal to the state MCL (0.5 µg/L); however, CCl_4 in all other source area wells was below 0.5 µg/L in April/May 2011.
- Perchlorate concentrations in MW-7 and MW-24 have declined from 4,810 and 4,880 µg/L to concentrations of 2.9 µg/L and 17.5 µg/L, respectively.
- The perchlorate concentration in MW-13 was 81.3 µg/L in April/May 2011. Perchlorate levels in this well have varied widely since commencing operation of the OU-1 in January 2005.

These data demonstrate that operation of the OU-1 treatment system has significantly reduced the chemical concentrations within the source area. The overall reduction in chemical mass within the source area will improve the effectiveness and efficiency of the off-facility (OU-3) remedy as required by the second remedial action objective. Although institutional controls are not a component of the Interim ROD, short-term protectiveness is assured through the operation of the treatment system and voluntary and regulatory groundwater use restrictions (groundwater basin adjudication, California Safe Drinking Water Act, etc.). It is anticipated that a Final ROD for groundwater will be issued prior to the next Five-Year Review that will include any active remedial actions and institutional controls necessary to provide long-term protection of human health and the environment.

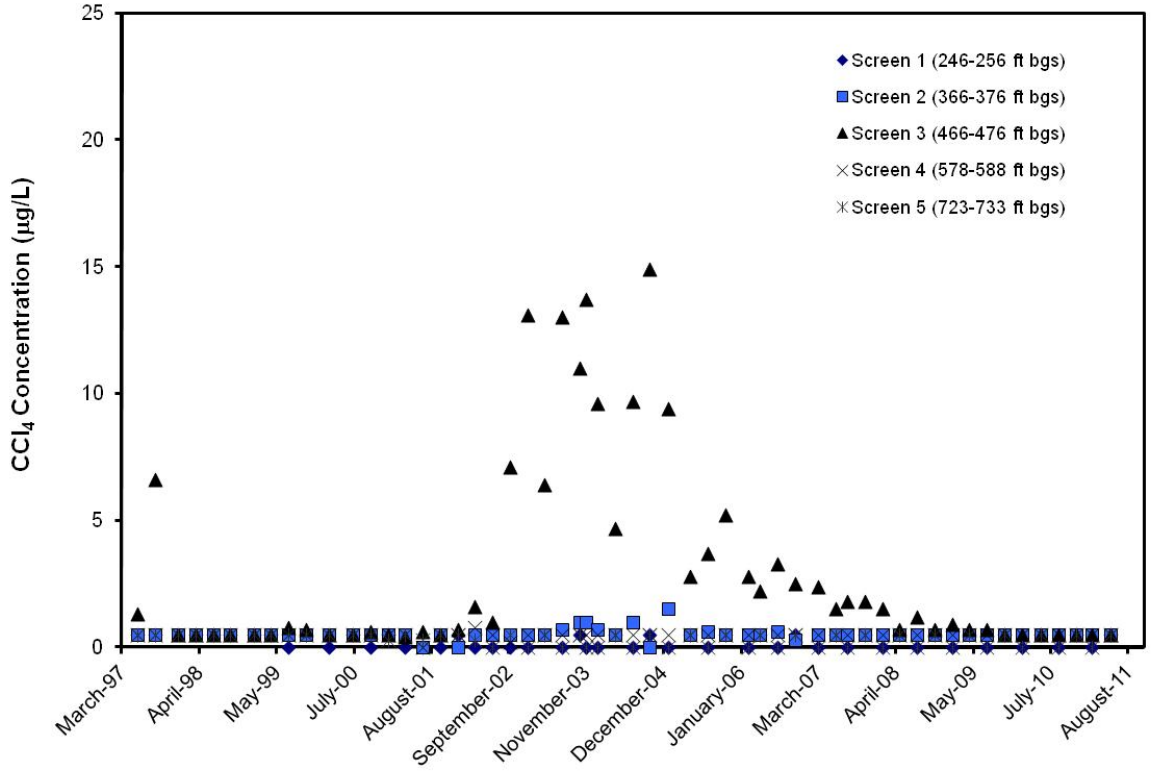
Figure 7-6. Historical Concentrations of Carbon Tetrachloride in MW-17

NASA JPL has a multiport monitoring well, MW-17, located less than 500 ft upgradient of LAWC#3. This monitoring well serves as the best available indicator of near-future (1-2 years) concentrations that may be observed in LAWC wells. Figures 7-6, 7-7, and 7-8 provide the historical concentrations of CCl_4, TCE, and perchlorate in MW-17. Analytical results of samples collected from MW-17 (Screens 2 and 3) indicated that the decreasing trend in perchlorate and CCl_4 concentrations continued through 2010. TCE concentrations in MW-17 continued to be relatively stable and below the MCL.

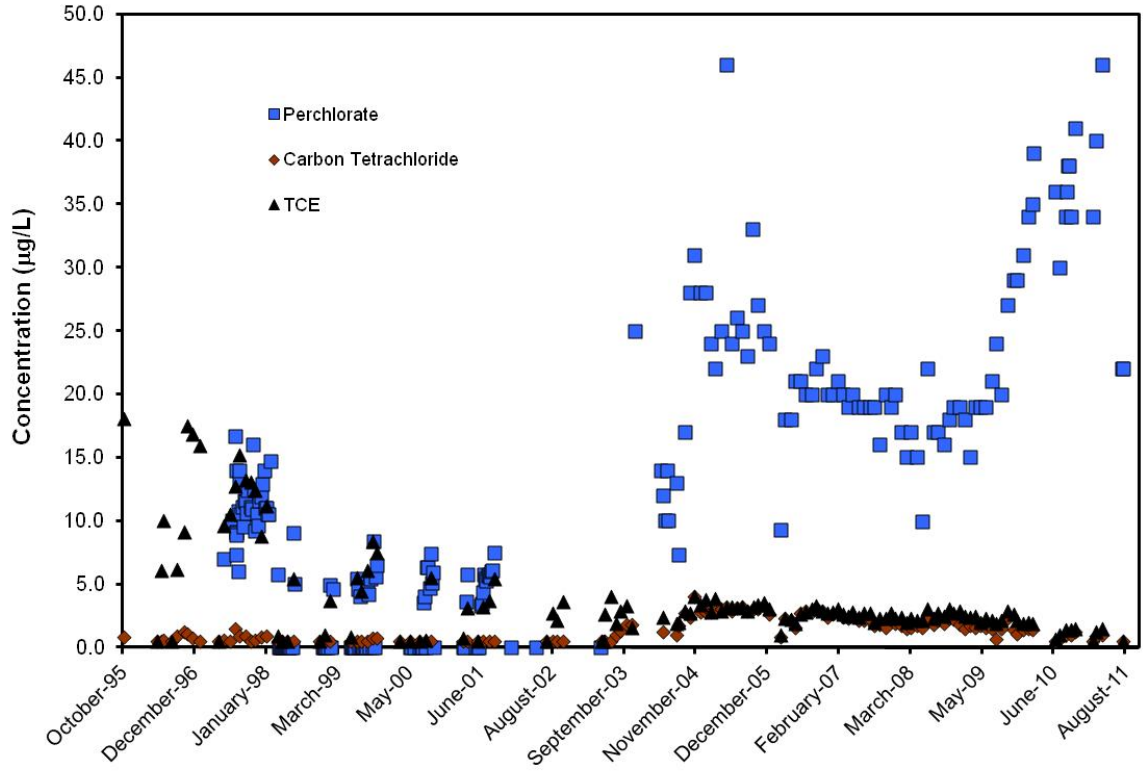
Figure 7-9. Carbon Tetrachloride, TCE, and Perchlorate Concentration Trends in LAWC#3

Figures 7-9 and 7-10 are graphs of the concentrations in extracted groundwater samples collected from LAWC#3 and LAWC#5. During the most recent reporting period (NASA, 2011c), LAWC#3 was in operation from July 2010 through March 2011 and LAWC#5 was operated only in March 2011 (after being offline since September 2009). Perchlorate concentrations in LAWC#3 ranged from 31 to 40 µg/L, with an average of 36 µg/L. Concentrations of CCl_4 and TCE were stable throughout the reporting period, averaging 1.2 µg/L and 1.8 µg/L, respectively.

As shown in Figure 7-9, perchlorate levels in LAWC#5 were higher in the March 2011 sample than in the samples from 2009. In fact, the March 2011 sample represents the highest level of perchlorate measured in LAWC#5. Perchlorate concentrations in LAWC#5 will be evaluated closely during the future operation of this well. Concentrations of TCE and CCl_4 in LAWC#5 were measured at 2.1 µg/L and 4.9 µg/L, respectively, in March 2011.

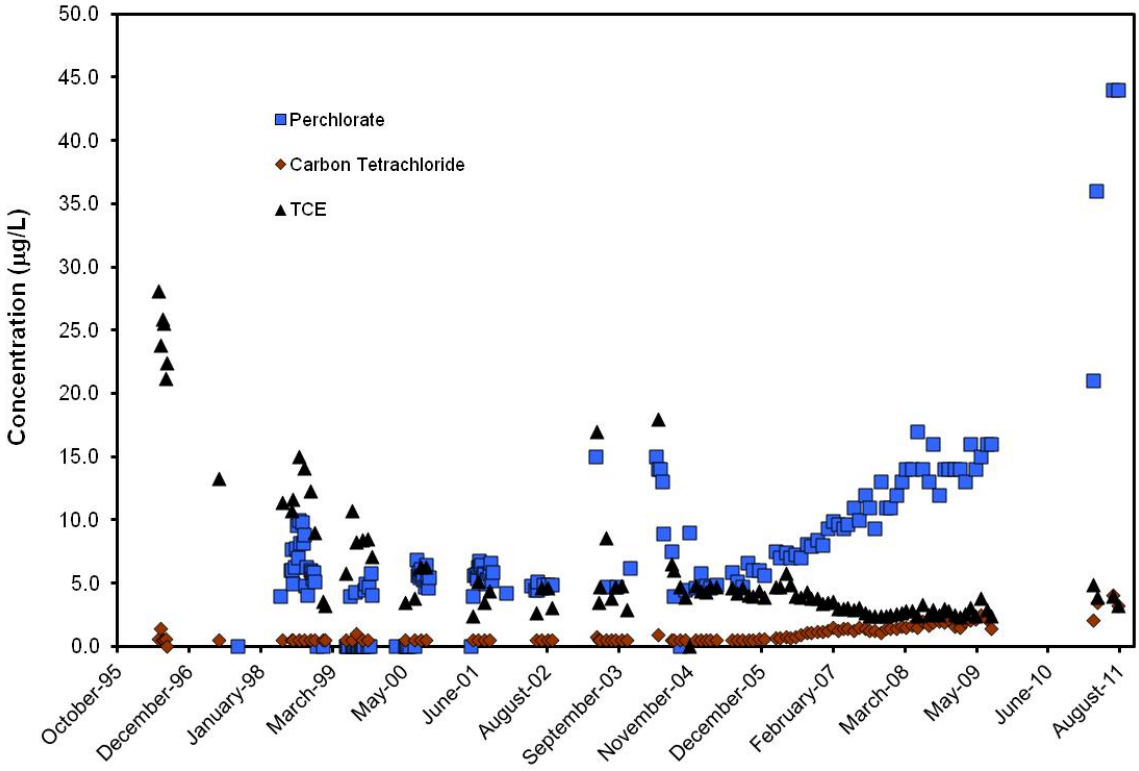
Figure 7-10. Carbon Tetrachloride, TCE, and Perchlorate Concentration Trends in LAWC#5

OU(s): OU-3	**Issue Category: Monitoring**			
	Issue: Increased perchlorate levels in production well LAWC#5			
	Recommendation: Evaluate future sampling results for LAWC#5 to monitor the perchlorate concentration trend at this well. The evaluation will be included in the next Technical Memorandum documenting performance of the LAWC treatment system.			
Affect Current Protectiveness	**Affect Future Protectiveness**	**Implementing Party**	**Oversight Party**	**Milestone Date**
No No		Monitoring by LAWC	Data evaluation and CERCLA reporting by NASA	April 2012

Recommendation	Proposed Implementation Dates	Party(ies) Responsible
Evaluate future sampling results for LAWC#5 to monitor the perchlorate concentration trend at this well. The evaluation will be included in the next Technical Memorandum documenting performance of the LAWC treatment system.	April 2012; Weekly sampling during operation of LAWC#5 will continue.	NASA is responsible for the evaluation and the technical memorandum. LAWC is responsible for weekly sampling and reporting to DPH.
Minimize nitrosamine leaching from virgin resin at the MHTS by minimizing the use of chlorinated water to flush the resin; pre-rinse newly installed resin prior to placing the vessel into service; perform subsequent monitoring for nitrosamines; develop best practices with the vendor for on-site maintenance activities to minimize the formation of nitrosamines; and require that the vendor pre-rinse resin at an off-site location prior to placing it in the MHTS vessels.	Effectively immediately during loading of virgin ion exchange resin.	Pasadena Water and Power to lead development of new standard operating procedures. Results of efforts to minimize nitrosamine leaching will be reported at the monthly CERCLA RPM meetings, as part of the treatment system performance update.

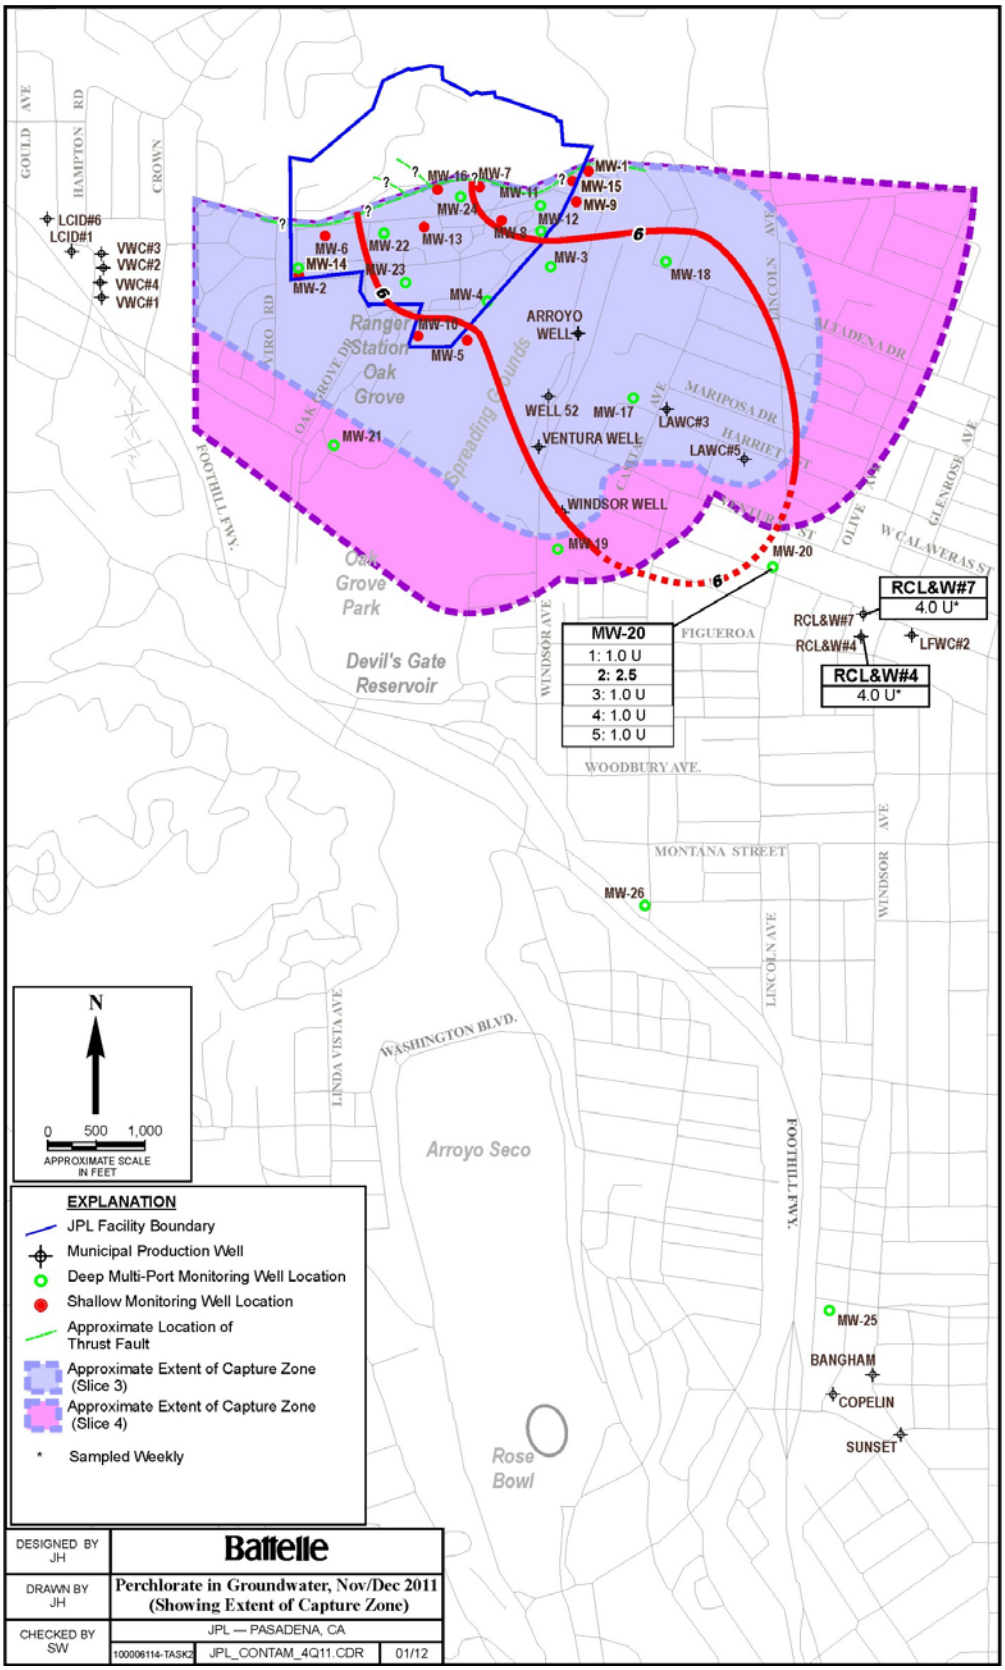
Figure 7-11. Capture Zones for the MHTS and LAWC Wells Relative to the Current Extent of Perchlorate in Groundwater Originating from JPL

Figure 7-11 shows the capture zones of the MHTS and LAWC wells relative to the estimated extent of perchlorate originating from JPL. The estimated extent of perchlorate conservatively represents all site-related chemicals. Although on Figure 7-11 the downgradient boundary of the perchlorate plume appears to extend past the LAWC and MHTS capture zones, it is an artifact of plume contouring using currently available data. Routine (i.e., weekly) monitoring is conducted at the Rubio Cañon Land and Water production wells, which are located downgradient of the LAWC wells, to verify the contaminant plume has not escaped the capture zones. The highest detection of perchlorate in these wells was 3.1 µg/L, and no increasing trends have been observed. Data from the Rubio Cañon Land and Water wells along with data from MW-17 demonstrate that operation of the LAWC treatment system is effectively preventing further migration of chemicals in groundwater. Based on the groundwater modeling, operation of the MHTS will further control migration of chemicals in groundwater (NASA, 2003).
