**DRAFT FINAL
FEASIBILITY STUDY REPORT
FOR OPERABLE UNIT 2:
POTENTIAL ON-SITE CONTAMINANT
SOURCE AREAS**

**NATIONAL AERONAUTICS AND SPACE ADMINISTRATION
JET PROPULSION LABORATORY
4800 Oak Grove Drive
Pasadena, California 91109**

July 2000

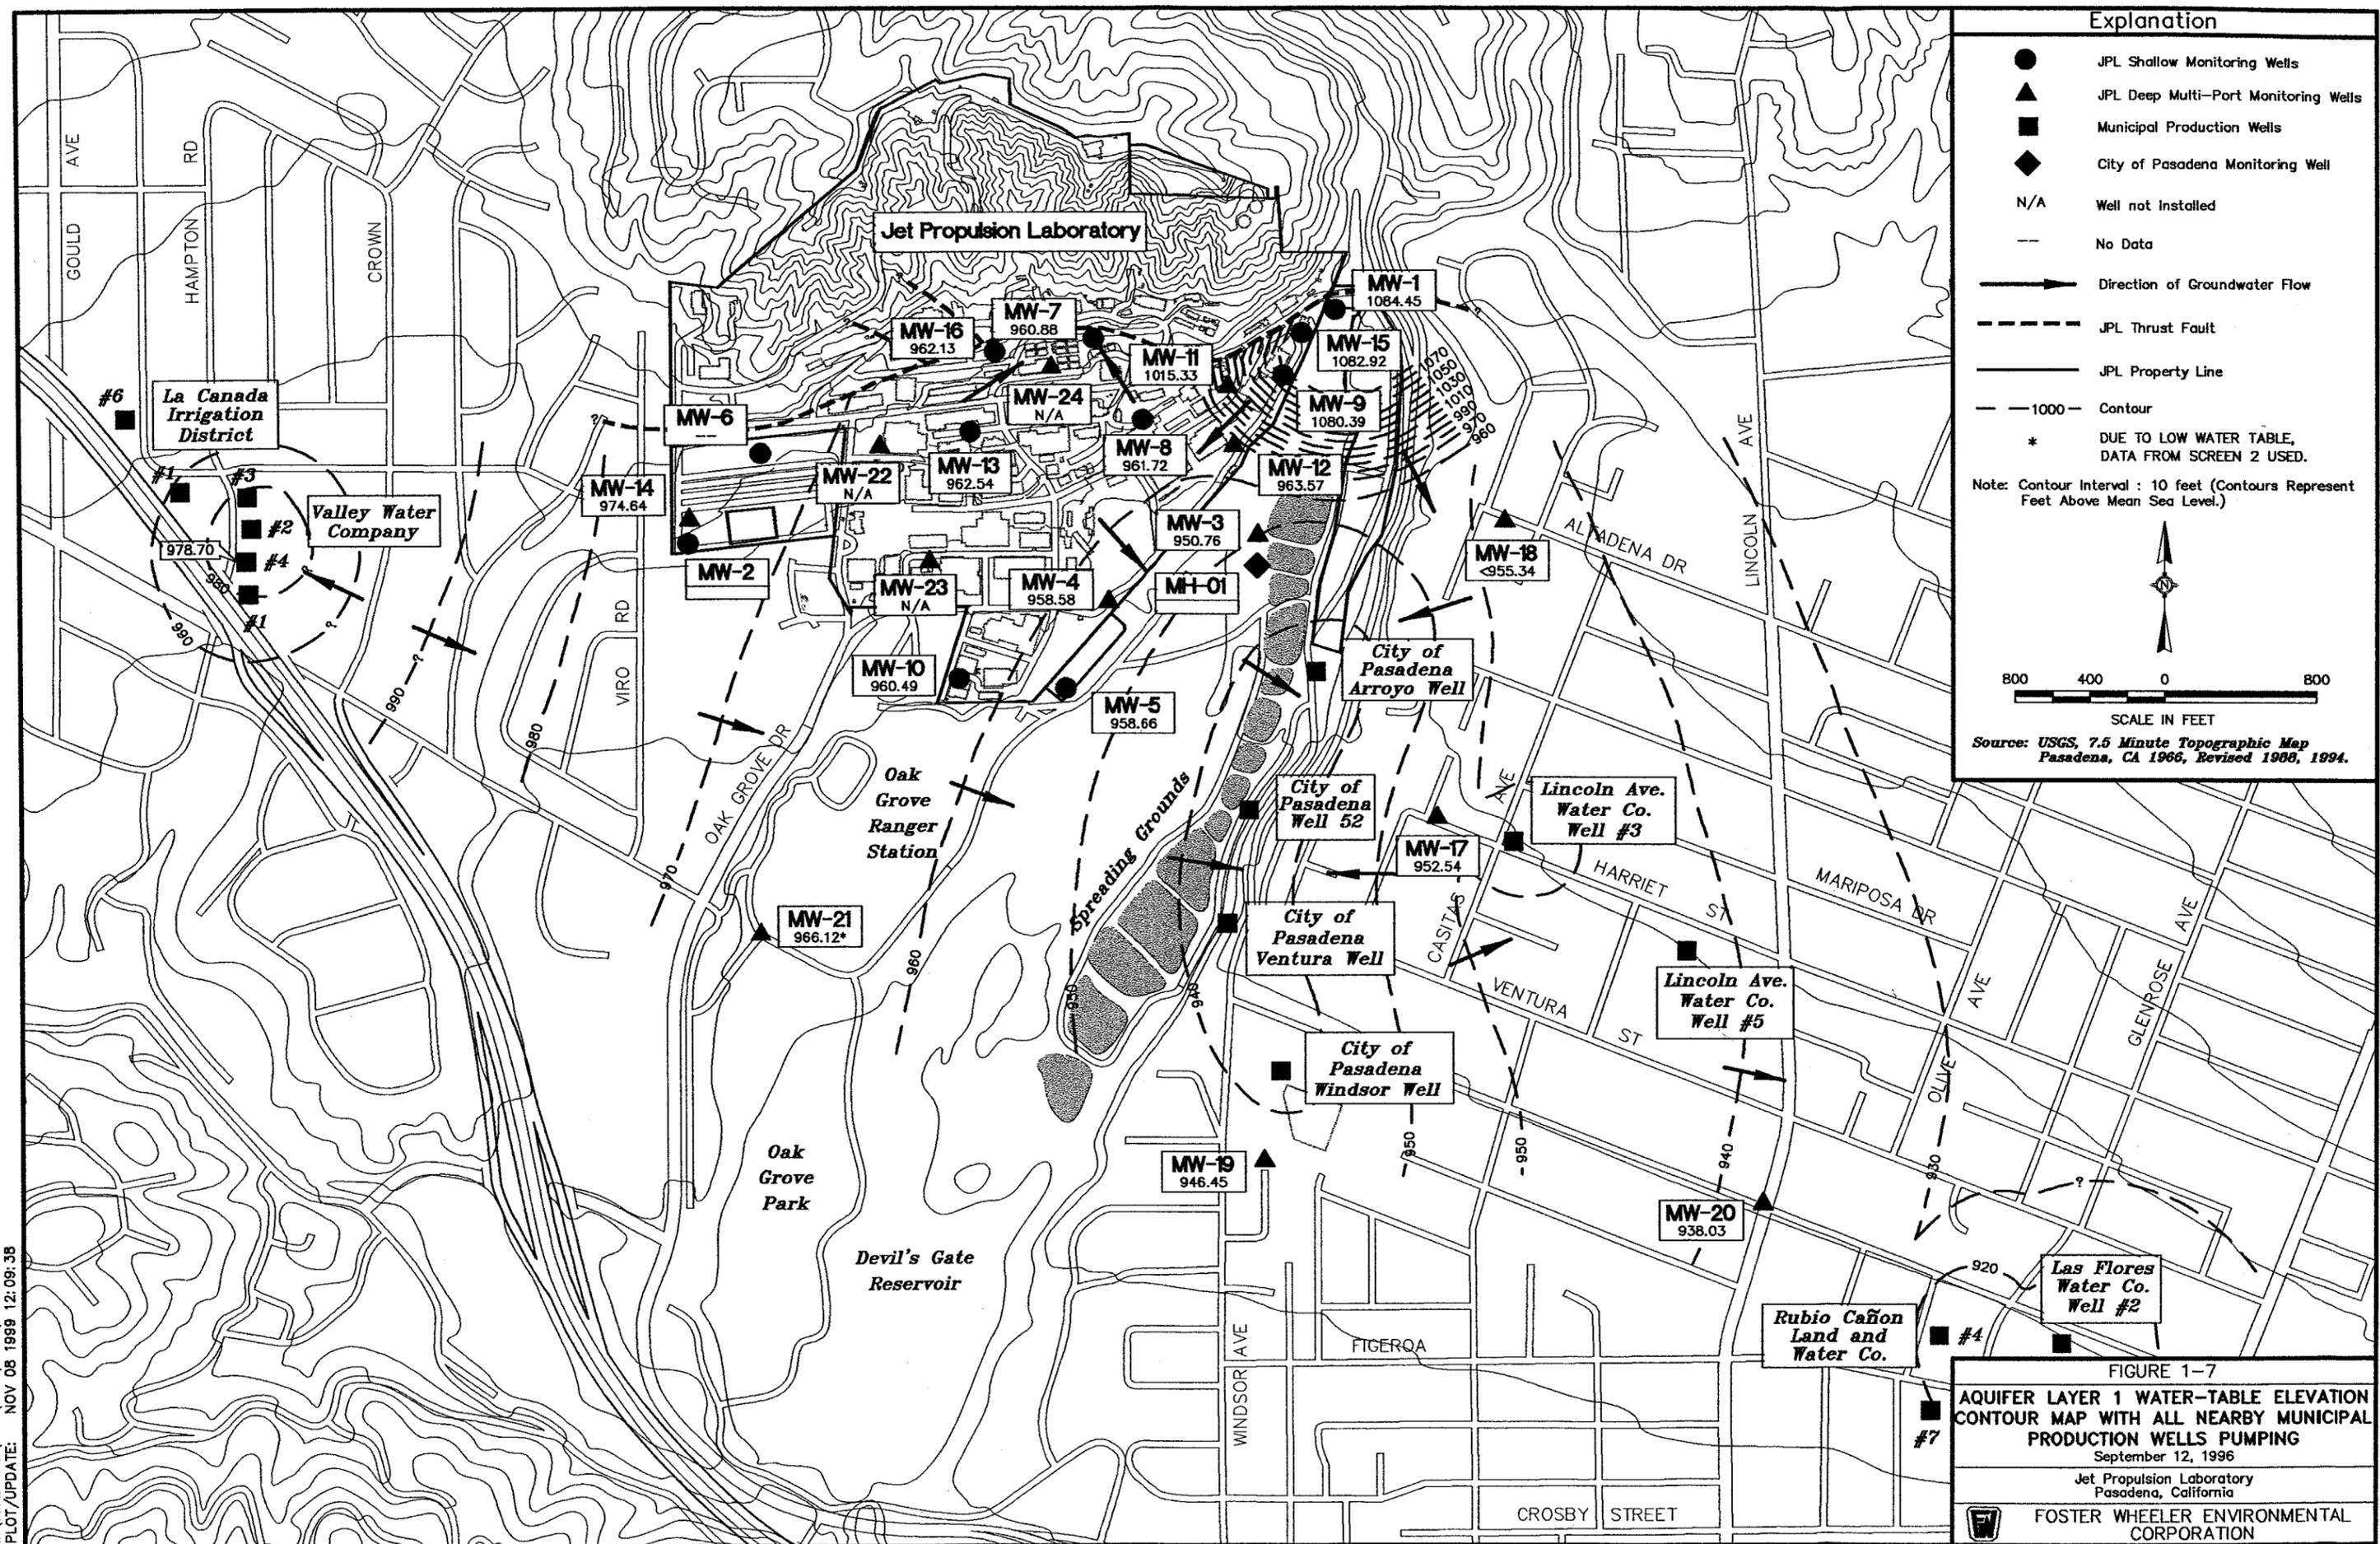
FIGURE 1-7
AQUIFER LAYER 1 WATER-TABLE ELEVATION CONTOUR MAP WITH ALL NEARBY MUNICIPAL PRODUCTION WELLS PUMPING
 September 12, 1996
 Jet Propulsion Laboratory
 Pasadena, California
 FOSTER WHEELER ENVIRONMENTAL CORPORATION

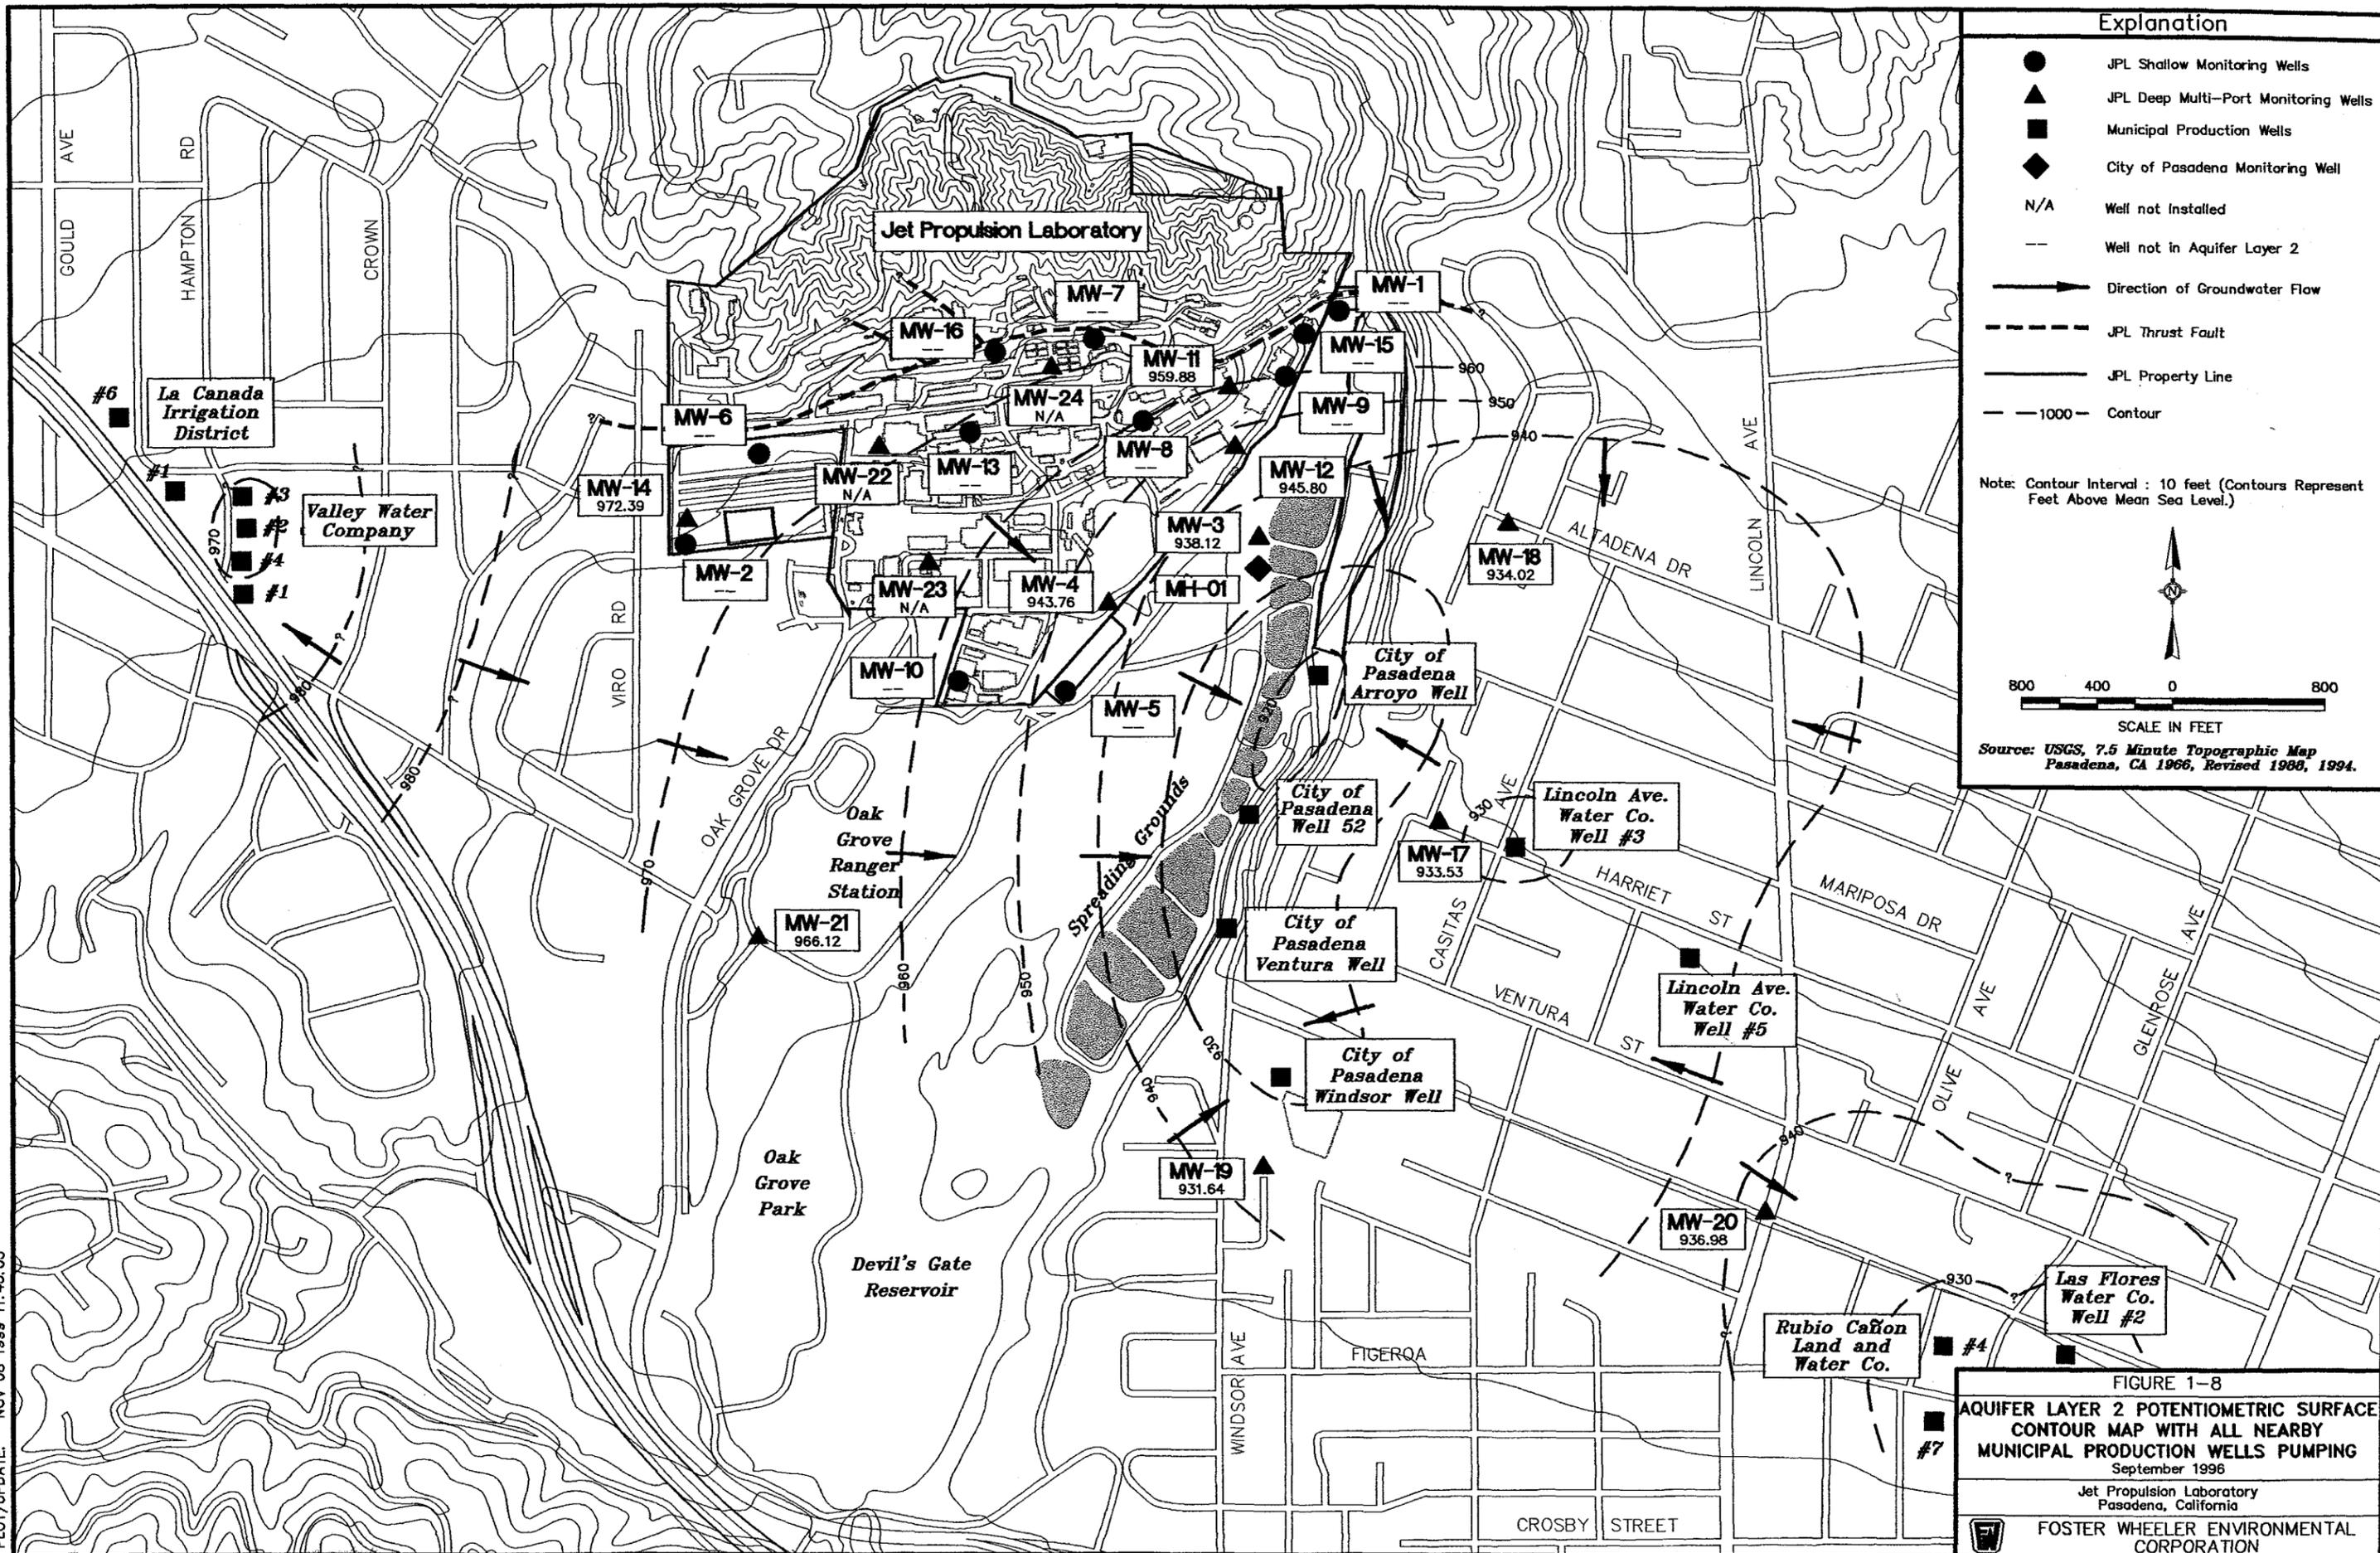
FIGURE 1-8
AQUIFER LAYER 2 POTENTIOMETRIC SURFACE CONTOUR MAP WITH ALL NEARBY MUNICIPAL PRODUCTION WELLS PUMPING
 September 1996
 Jet Propulsion Laboratory
 Pasadena, California
 FOSTER WHEELER ENVIRONMENTAL CORPORATION

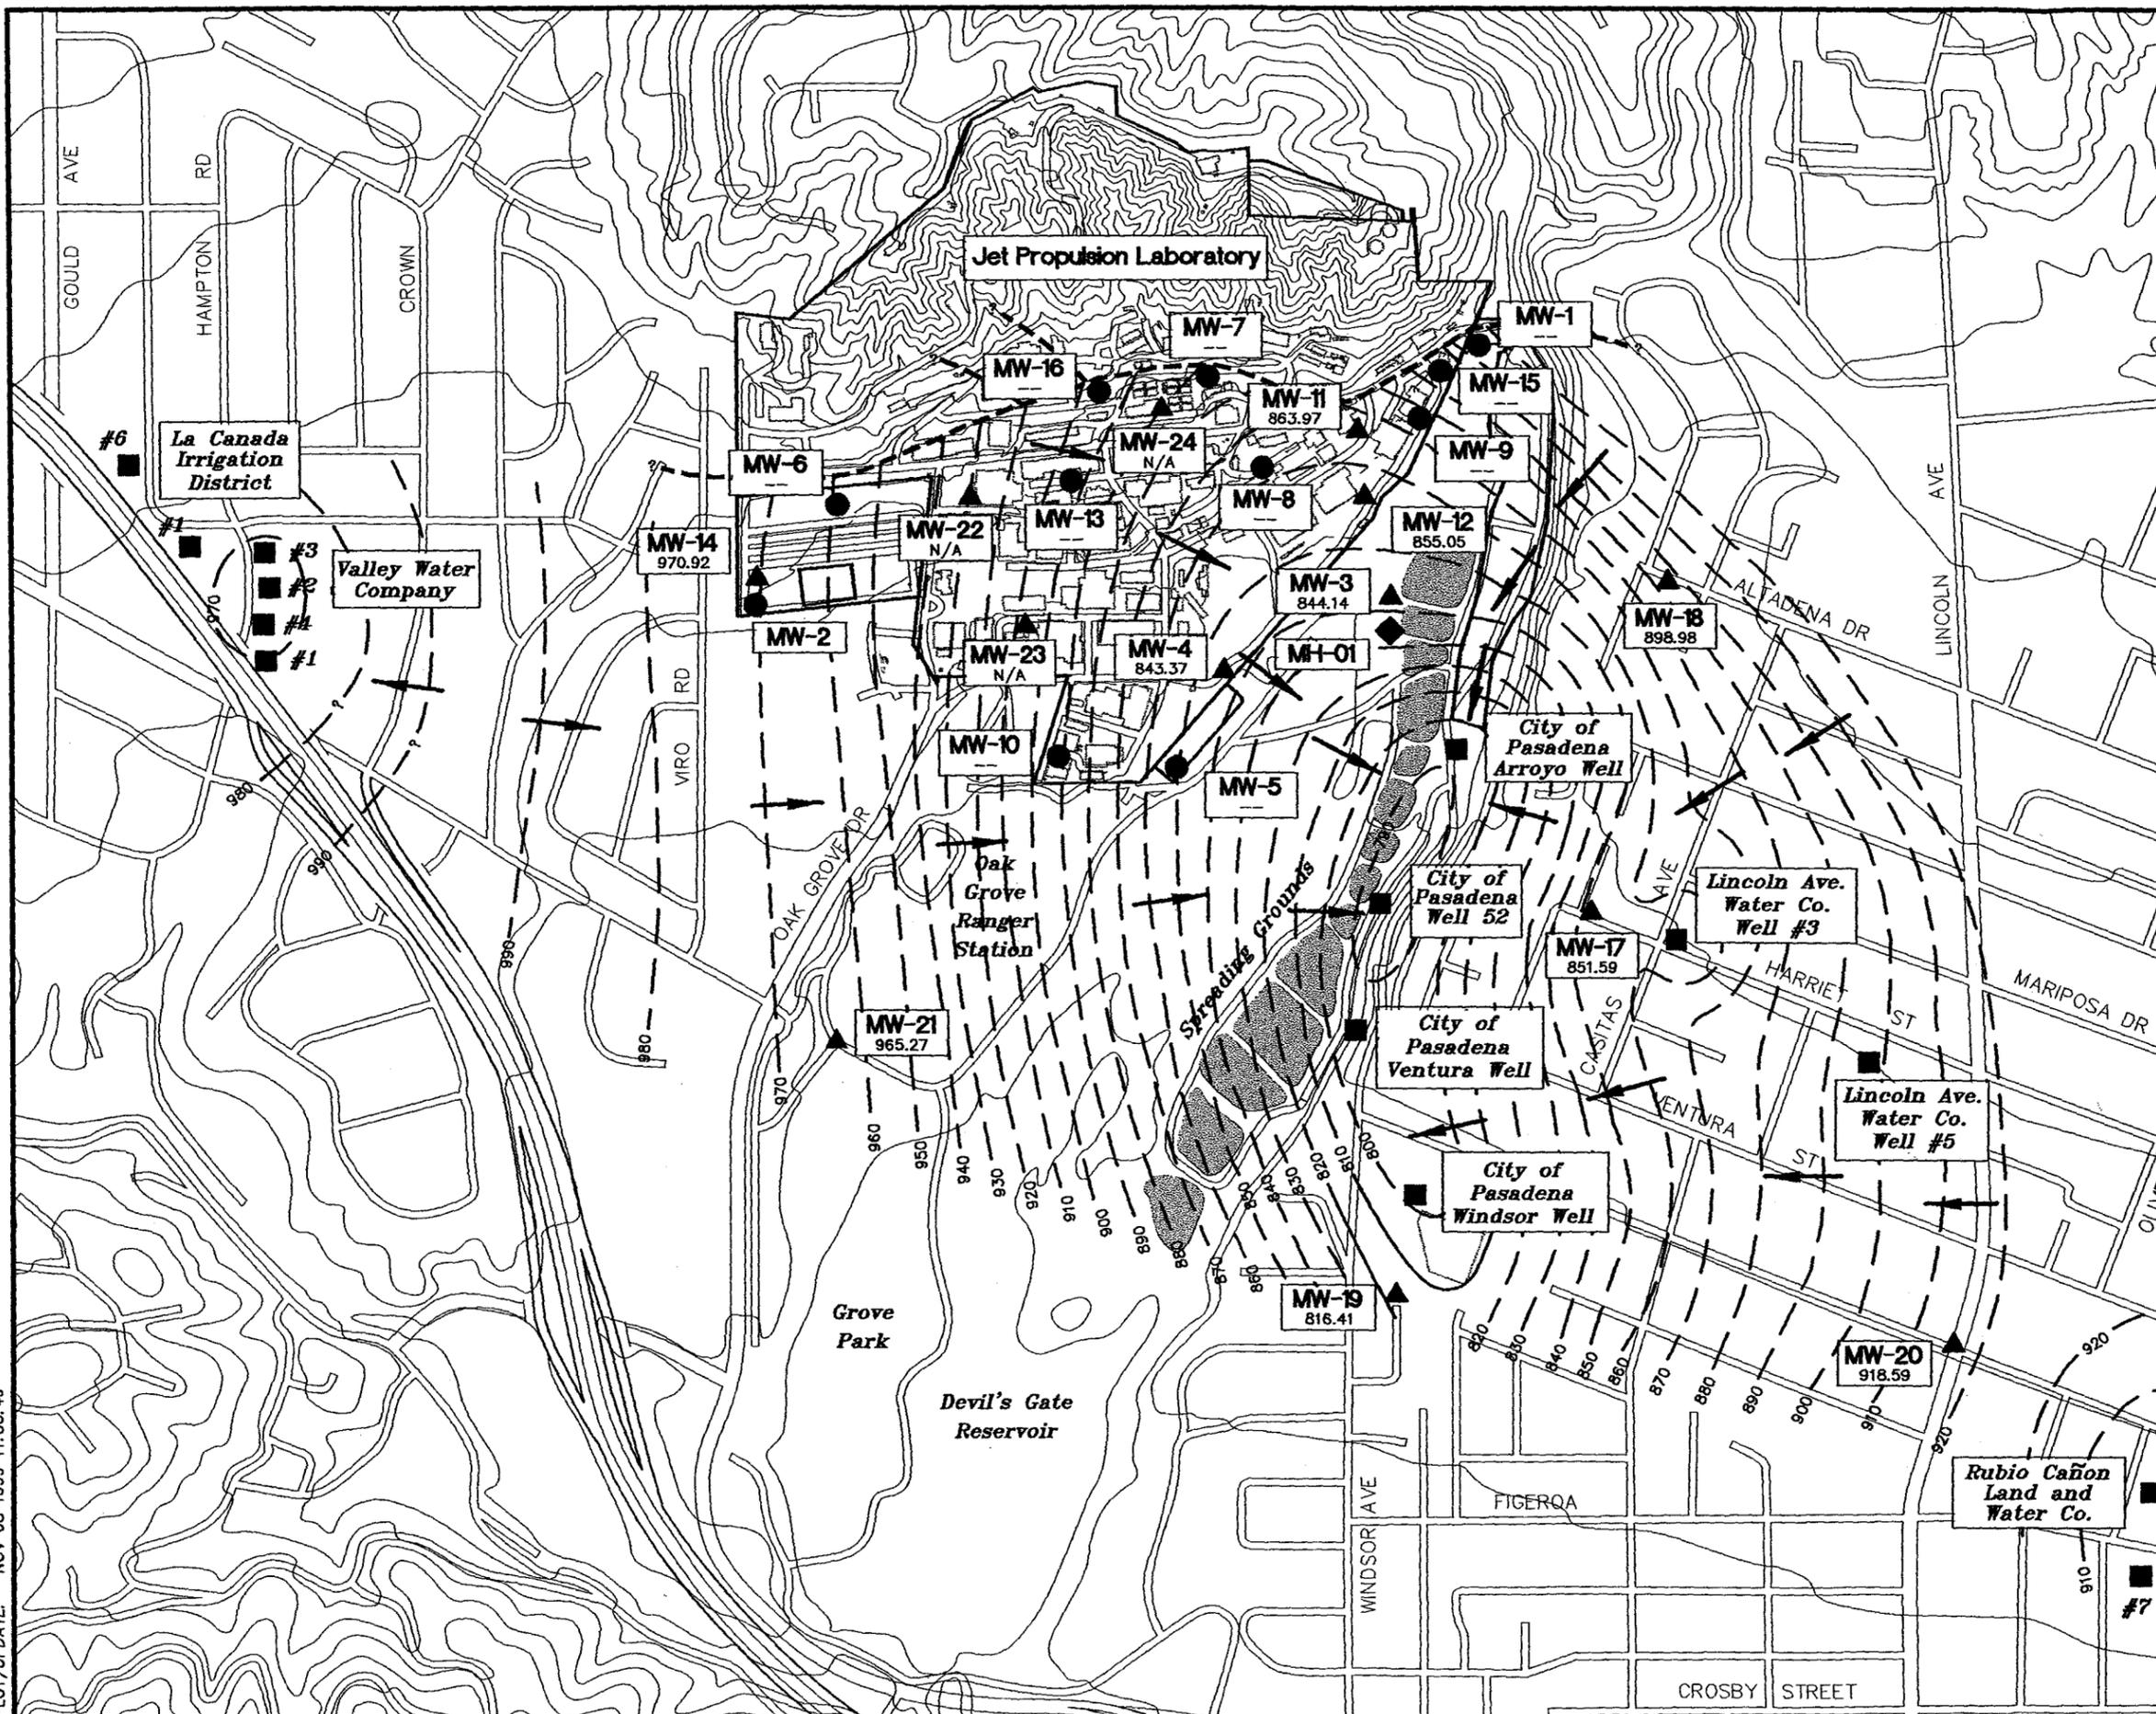
FIGURE 1-9
**AQUIFER LAYER 3 POTENTIOMETRIC SURFACE
 CONTOUR MAP WITH ALL NEARBY
 MUNICIPAL PRODUCTION WELLS PUMPING**
 September 1996
 Jet Propulsion Laboratory
 Pasadena, California
**FOSTER WHEELER ENVIRONMENTAL
 CORPORATION**

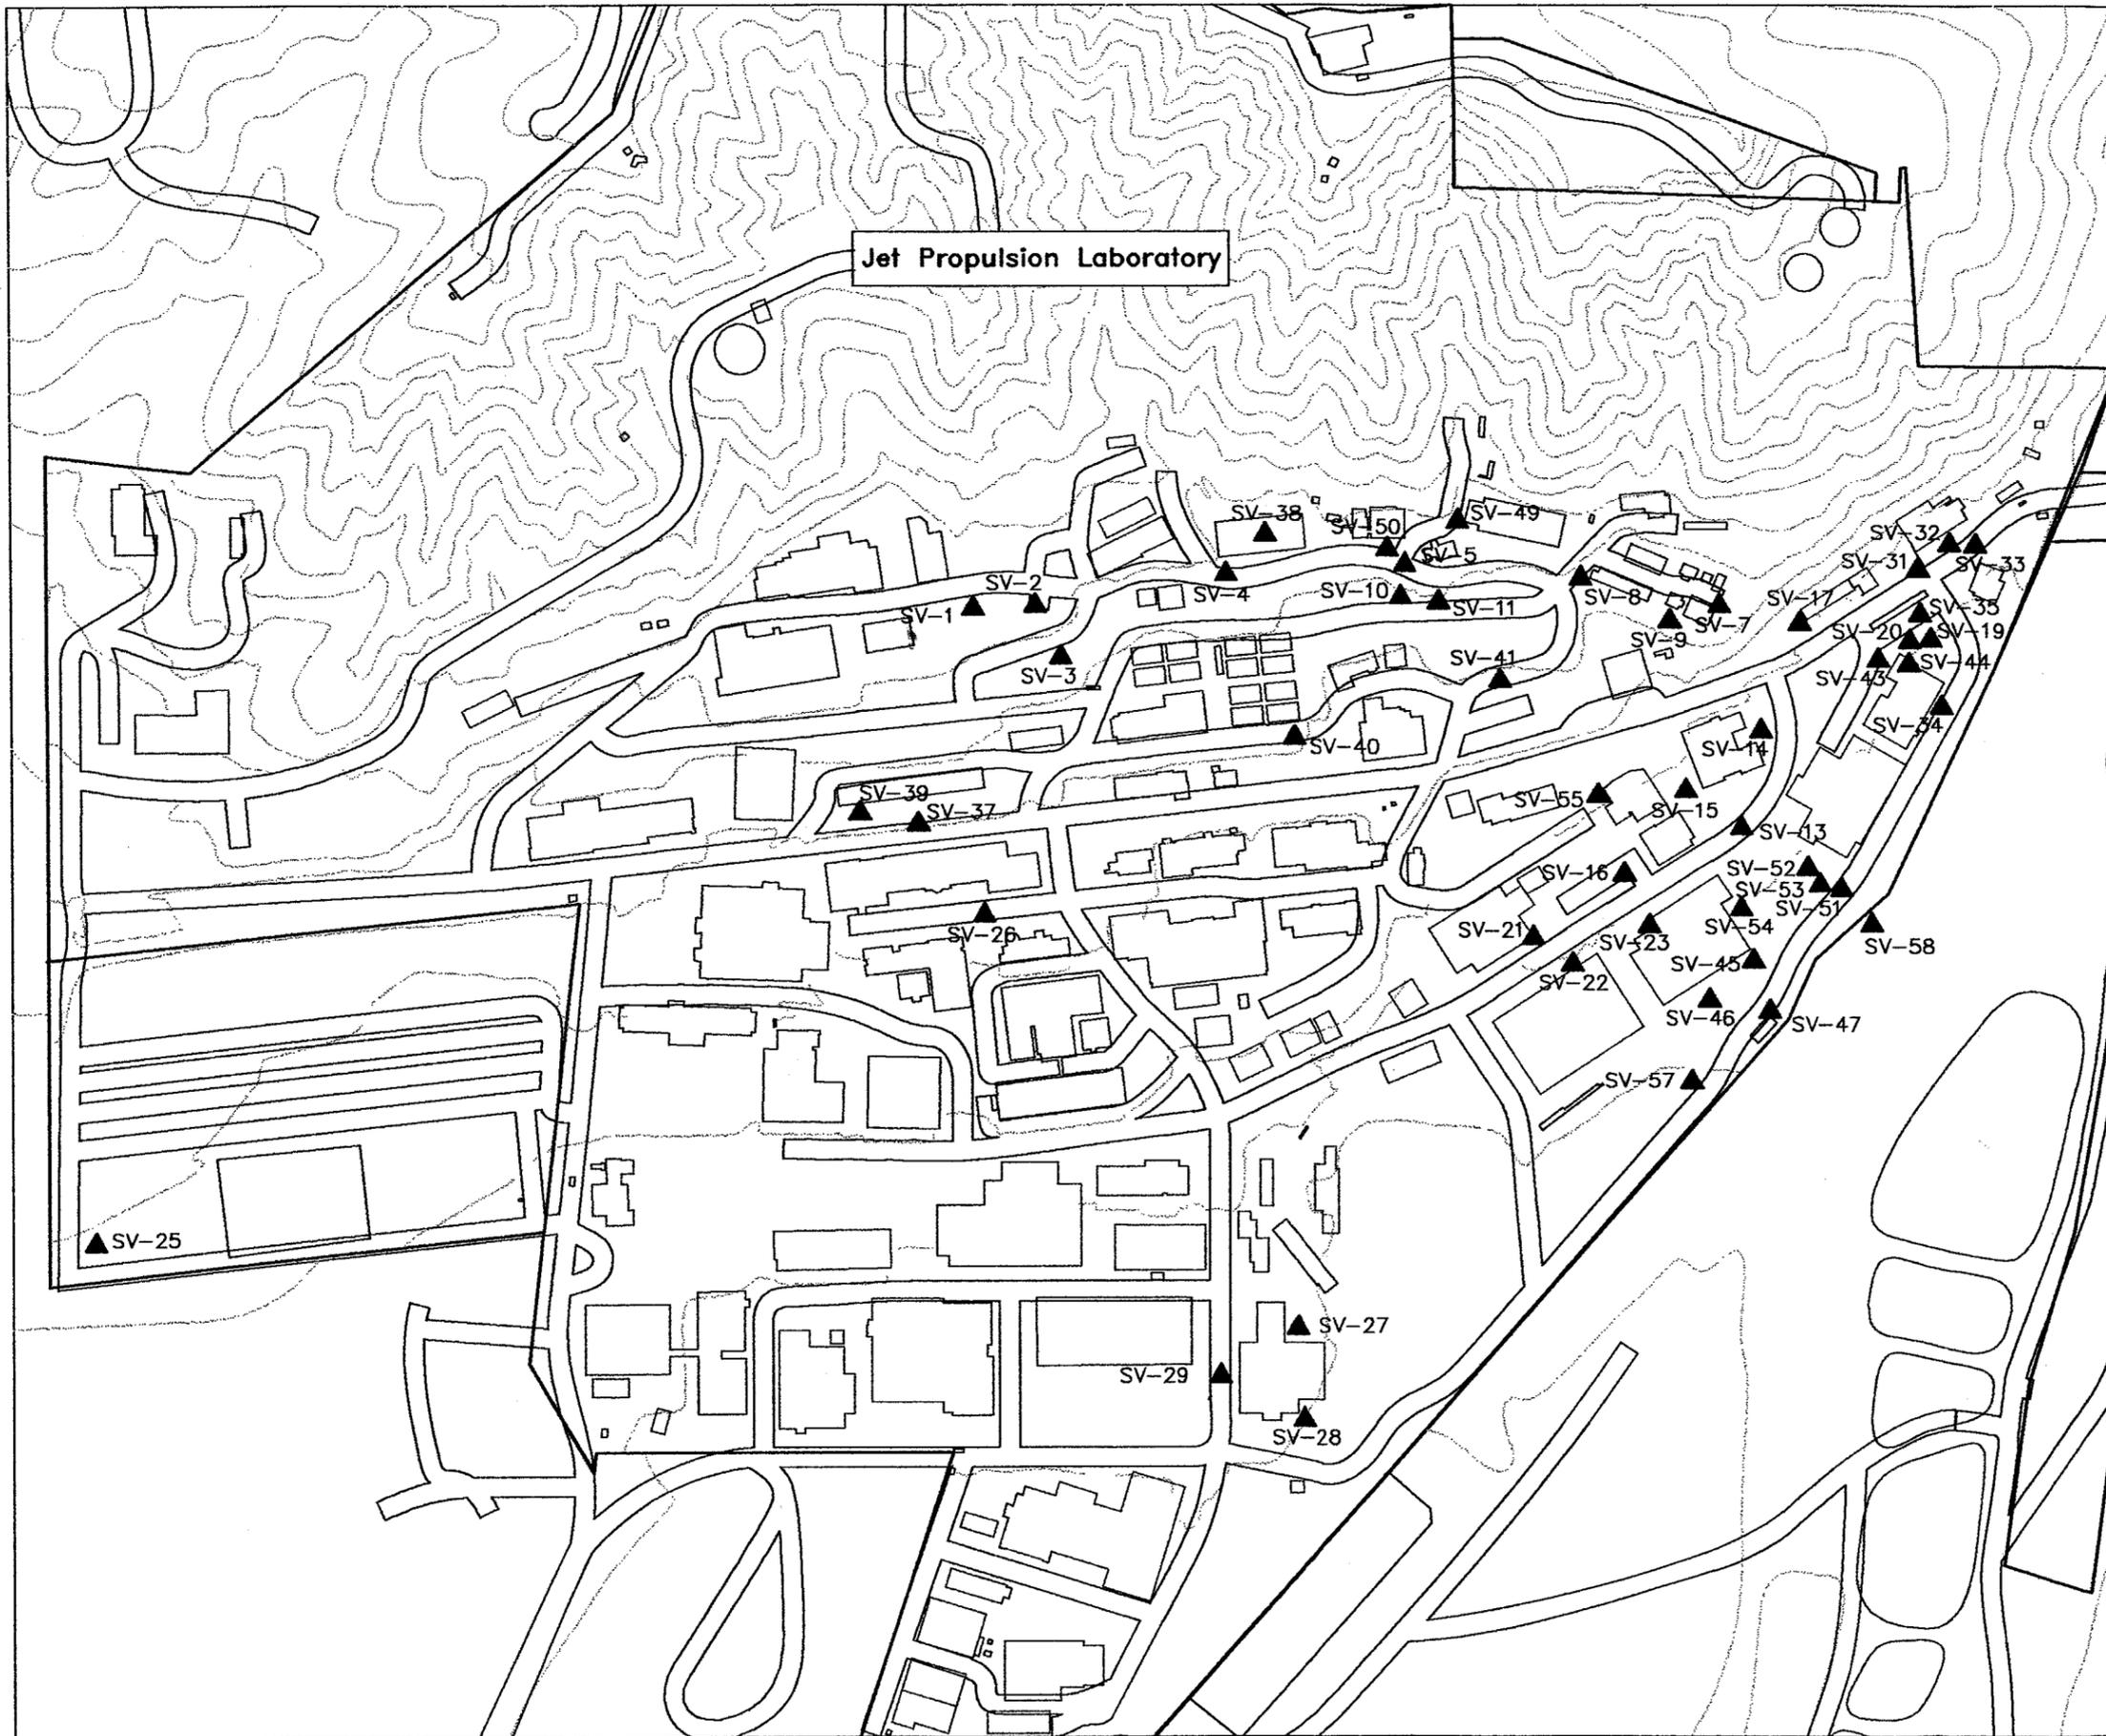
FIGURE 1-11
LOCATIONS OF SOIL VAPOR PROBES SAMPLED DURING THE INITIAL SCREENING, EVENT 1
January, 1994
Jet Propulsion Laboratory
Pasadena, California
FOSTER WHEELER ENVIRONMENTAL CORPORATION

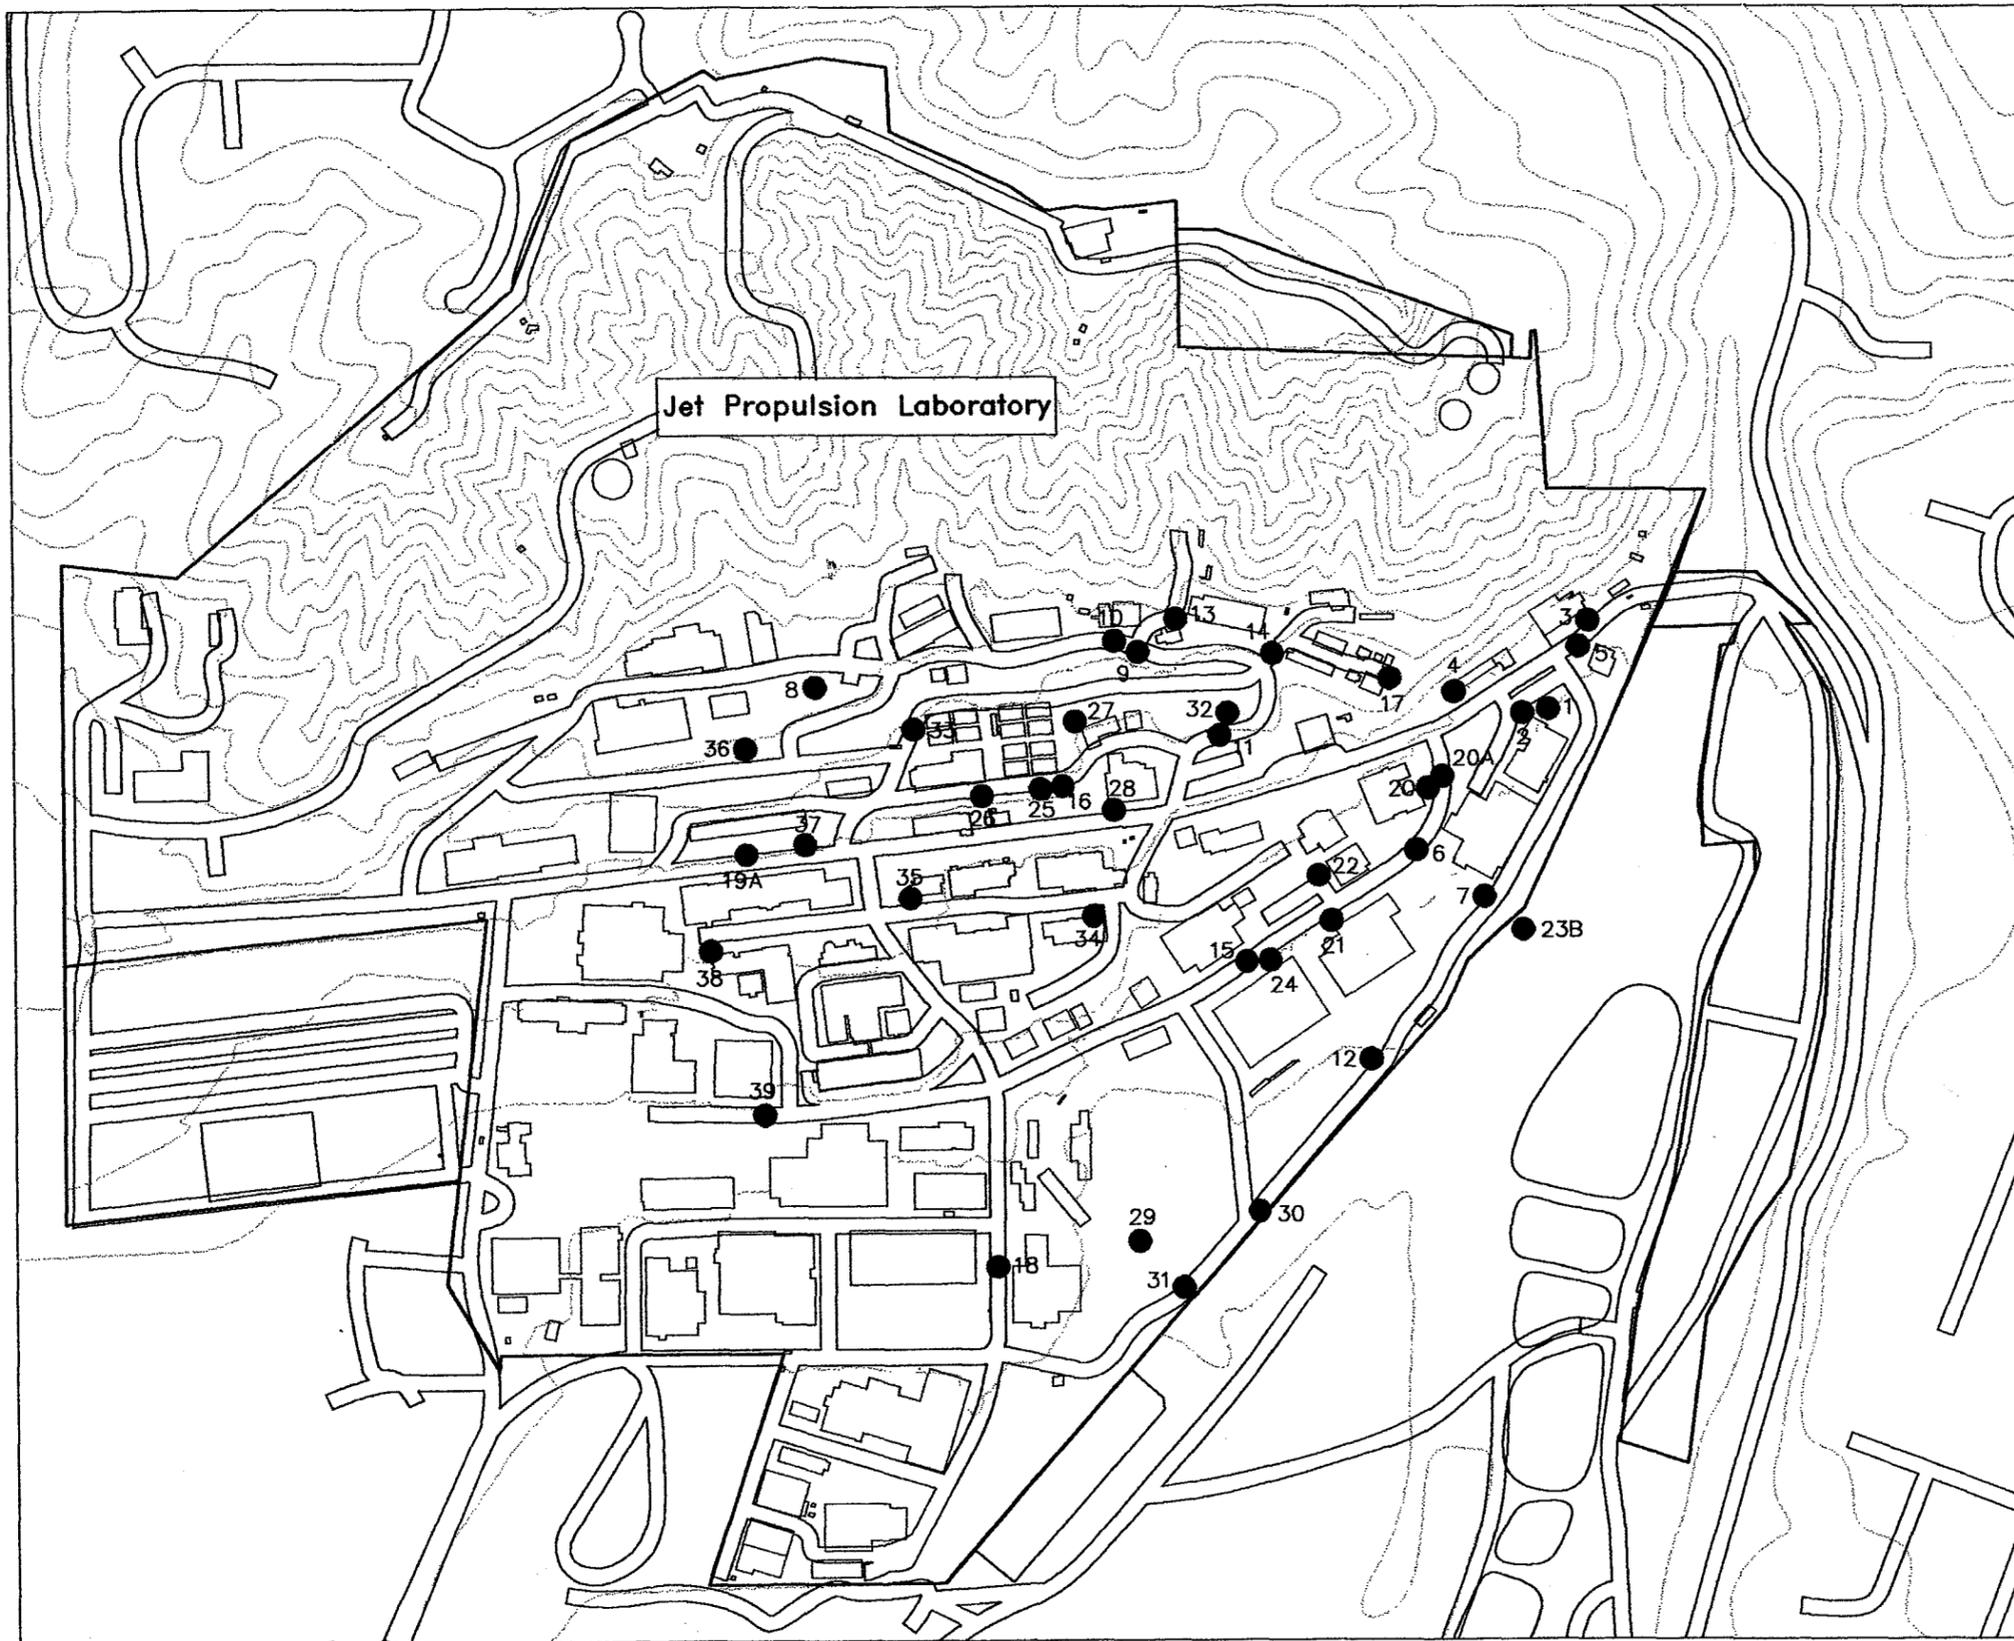
FIGURE 1-13

- 39 Soil Vapor Well Installed During RI Investigation

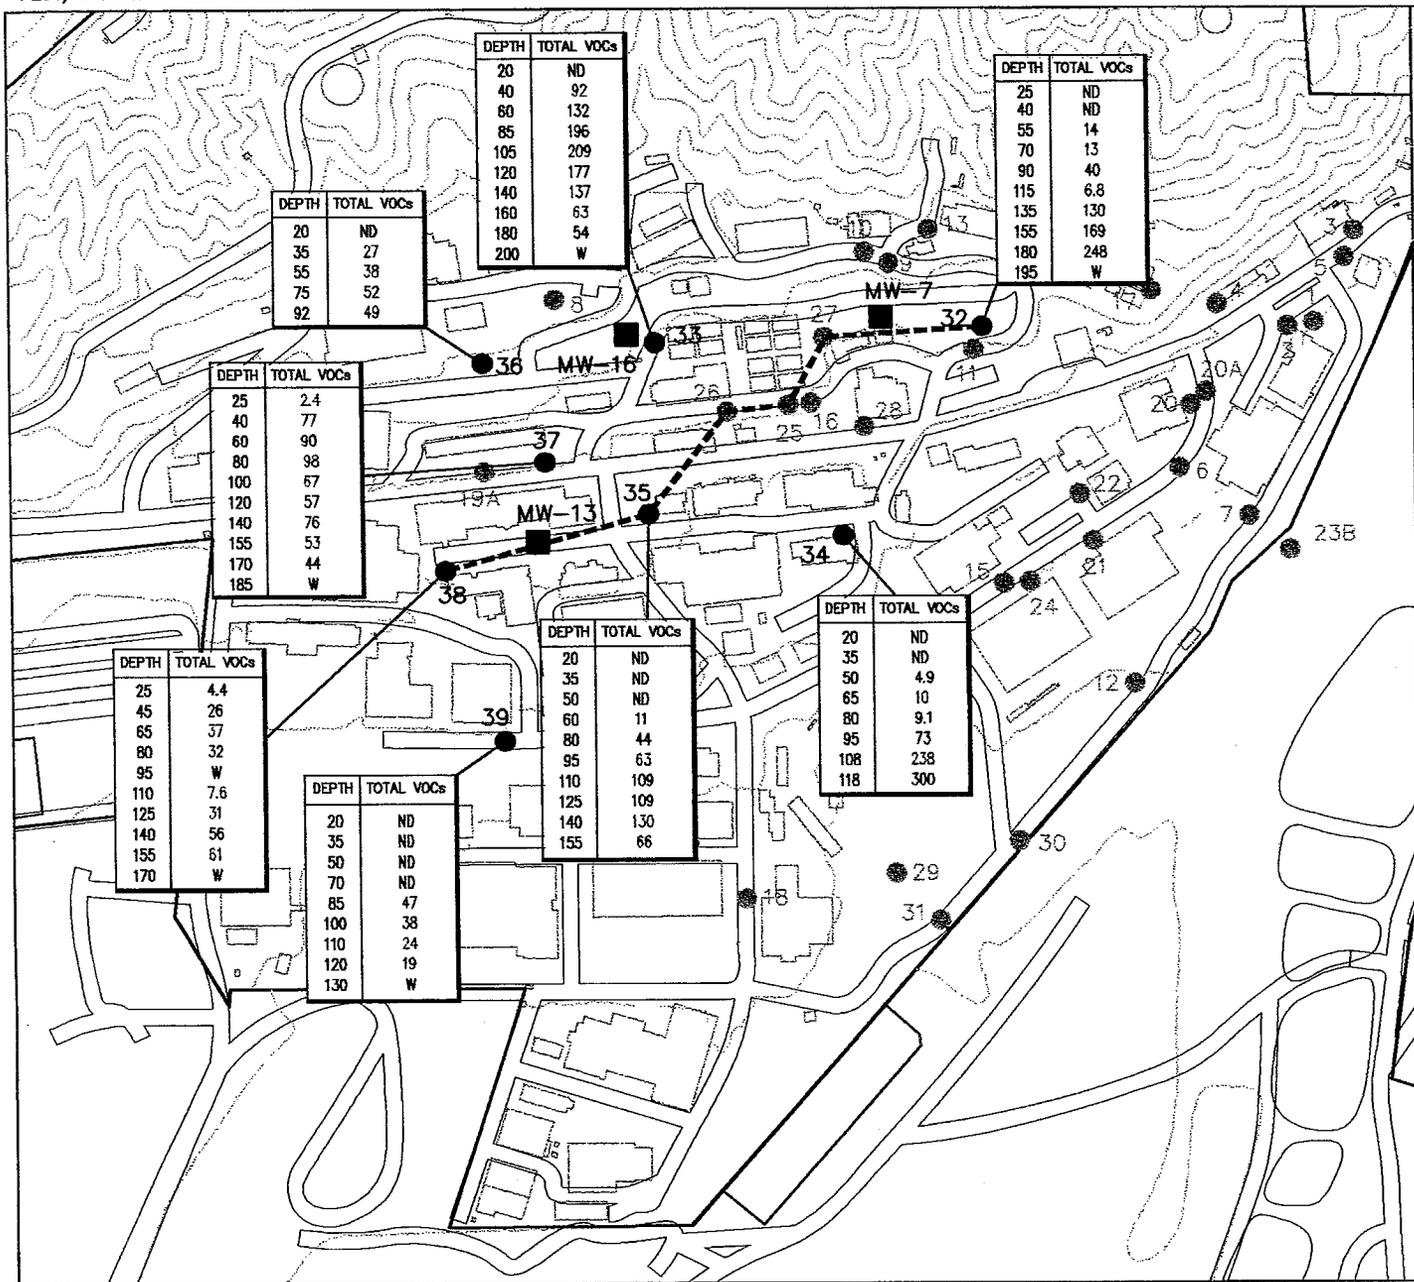
FIGURE 1-14
TOTAL VOC CONCENTRATIONS AT DEPTH, EVENT 7
 JUNE, 1998
 Jet Propulsion Laboratory
 Pasadena, California
 FOSTER WHEELER ENVIRONMENTAL CORPORATION
